BROOKLANDS AERODROME & MOTOR RACING CIRCUIT

CONSERVATION MANAGEMENT PLAN

Brooklands Heritage Partnership

October 2017

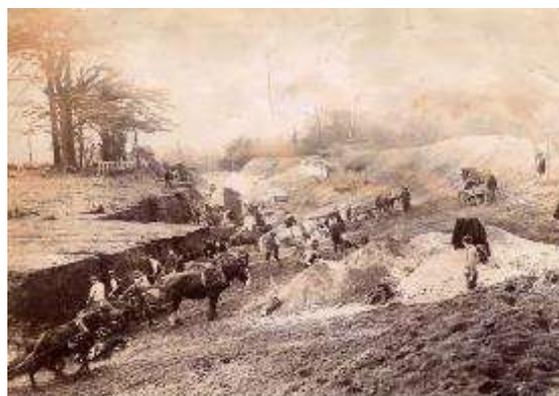
Fig 3.2 – Construction of the north end of the race track in 1906

- 3.2.9 The overall oval form of the circuit built with the 6 inch thick unreinforced concrete, was 100 feet wide for its entire 2¾ miles (4.4 kilometres) perimeter length. It consisted of the two steeply banked bends at the north-east and south-west ends (Members' or Home Banking and the Byfleet Banking respectively), which were connected by the Railway Straight on the north-west side and a soft reverse curve section the south-east side – a straight wasn't achievable here as Locke King had already sold off the adjoining parcels of land (this is where the Itala Works was established, discussed later). Towards the south-east end of the Byfleet Banking, the 'Fork' was created to allow the ½ mile (0.8 kilometre) long Finishing Straight to follow a northerly axis and link directly to the Members' Banking.

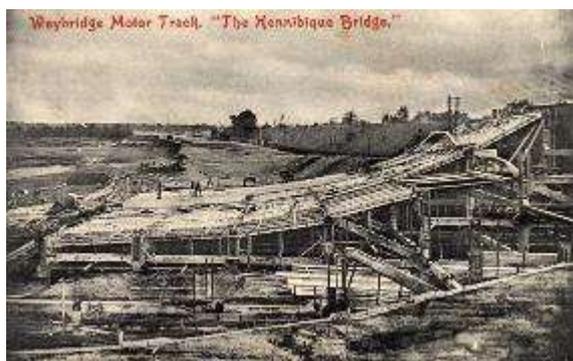
Fig. 3.3 – Hennebique Bridge under construction
(© via Brooklands Museum)

- 3.2.10 The River Wey presented a significant obstacle for the track at its north end. However, advice was swiftly sought from L G Mouchel & Partners, who were the British agents for the Hennebique method of reinforced concrete construction, a process which had been developed and patented by Francois Hennebique in 1892. This resulted in the 180 feet span across the River being achieved with a pioneering steel reinforced concrete structure consisting of five arches, which became known as the 'Hennebique Bridge'.

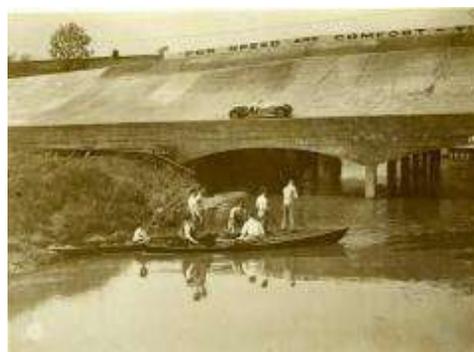
Fig 3.4 – The completed Hennebique Bridge
(© via Brooklands Museum)

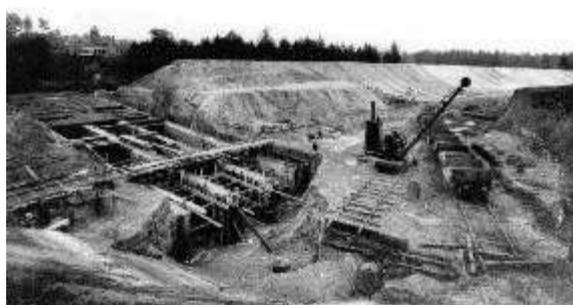
Fig 3.5 – Spectator’s Tunnel under construction
(© via Brooklands Museum)

3.2.11 During the development of the design and the construction of the track, access for vehicles and spectators were obviously important factors. This was achieved with two tunnels and a bridge being constructed at the Weybridge end of the circuit, due to the railway connection nearby, before the track surface was laid above. At the north end of the race track was the ‘Motor Tunnel’, more commonly known as the ‘Shell Way Tunnel’ or ‘Competitors’ Tunnel’. This consisted of a single carriageway for use by motor cars, especially competitors’ vehicles, providing direct access to the Paddock area. From 1912 this route also led to the Flying Village via Aerodrome Road and was presumably also used by aviators too. The second tunnel, on the north-east side of Members’ Hill, was for pedestrians and provided access for spectators through a series of three interlinked parallel passageways – each lined with white tiles to improve the quality of light and their appearance to the spectators³. Finally, the BARC members were provided with their own access above the track via ‘Members’ Bridge’ a steel-framed structure, supplied by Head Wrightson & Co. Ltd. of Thornaby-on-Tees⁴.

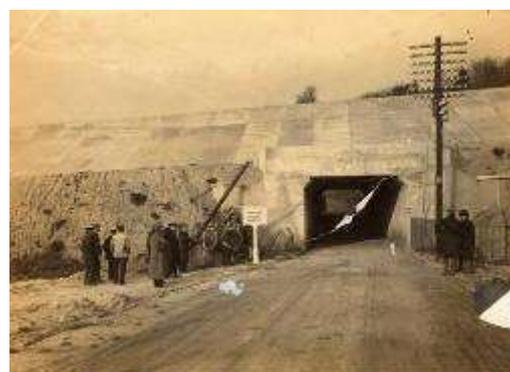
Fig 3.6 – Competitors’ Tunnel in 1908
(© via Brooklands Museum)

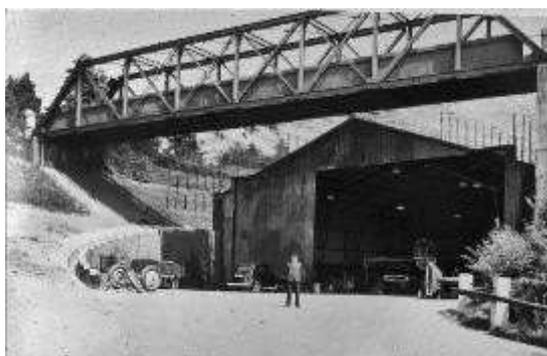
Fig. 3.16 – Hangar T194 photographed with a Wellington bomber fuselage under construction inside (WW2).
(© BAE Systems via Brooklands Museum)

- 3.2.30 The purpose of hangar T202 was specifically for the dispersed manufacture of Vickers Wellington MkII and Warwick aircraft, and part of a production sequence linked to another (non-Bellman) hangar, later known as T194, located on the Outer Circuit under the Members' Bridge. Incomplete new fuselages were towed into the north end of the Bellman Hangar, before being finished and rolled out of the south doors for engine ground runs on the apron. They were then able to access the aerodrome via a new taxi-way built from the Finishing Straight around the north side of the Clubhouse and then crossing the river over a new steel bridge (still extant).

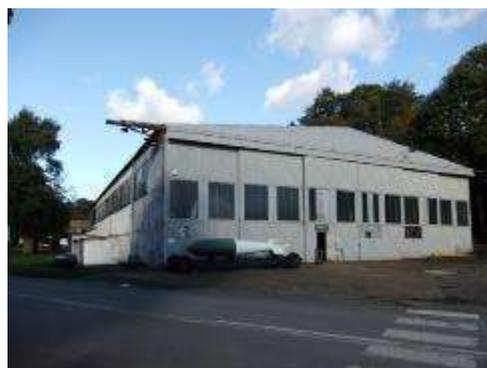
Fig. 3.17 – Bellman Hangar T202 on the Finishing Straight.
(Radley House Partnership)

- 3.2.29 As part of the rapid site development a series of up to 10 temporary Air Ministry Bellman hangars were erected at different locations around the circuit for aircraft production and as repair facilities for the Vickers-Armstrong's (Aircraft) Limited and the Hawker Aircraft Ltd factories. Until 2004 two of the Vickers hangars were still in existence, one located on the Railway Straight (now demolished) and the other (which still remains today on the Museum site) on top of the Finishing Straight between the Clubhouse and Members' Hill. The extant hangar (later known as T202) was ordered on 16 September 1940 just 12 days after a devastating German air raid on the Vickers Works and built between September and December the same year.

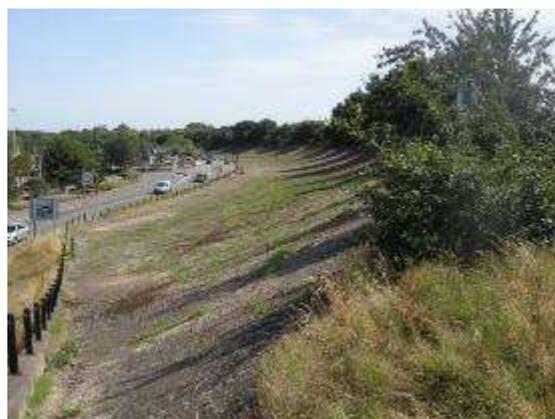
Fig 4.2 – Southern section of the former Byfleet Banking
(Radley House Partnership)

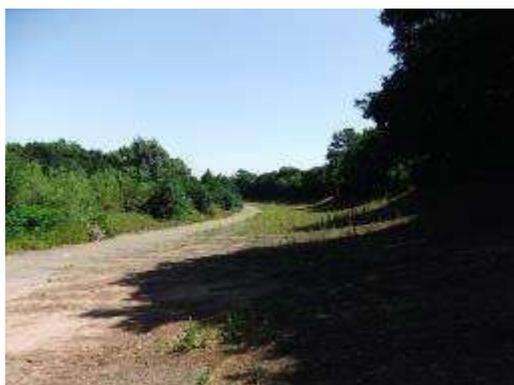
Fig 4.3 – South-eastern section of the former Byfleet Banking within the Brooklands Community Park
(Radley House Partnership)

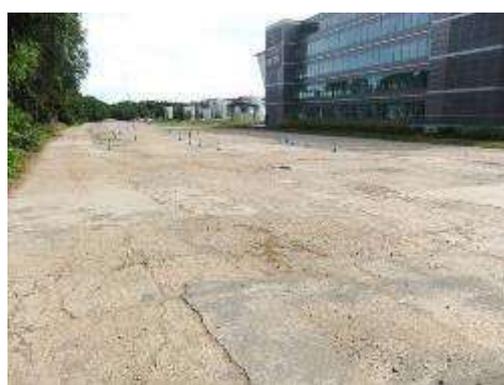
Fig 4.4 – Extant section of the former Railway Straight
(Radley House Partnership)

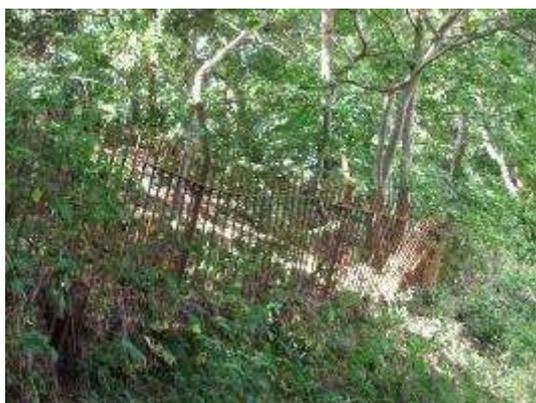
Fig 4.5 – Original 'Bayliss' Boundary Railings,
north of the Members' Banking
(Radley House Partnership)

In designing the circuit, it was proposed to be enclosed with a series of boundary treatments positioned at the base of the support banking or track edge (where flat), including a 'Bayliss' Iron fence, corrugated iron fence and an oak fence. Of these three proposals, only the 'Bayliss' fence survives to different degrees around the track, most notably to the south-east section of Byfleet Banking in the Community Park with smaller sections interlinked with 'modern' replacement fencing along the bottom of the support bank behind the Members' Banking at the north end.

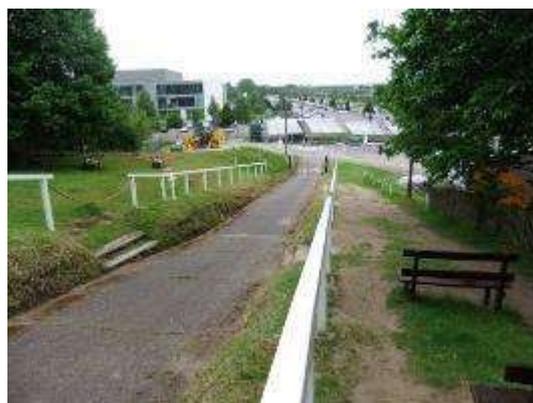
Fig 4.6 – Test Hill
(Radley House Partnership)

- 4.2.10 Although not part of the original 1907 Race Track, the complete remains of the Test Hill added after 1909 is further important evidential value to the understanding of the evolution and development of Brooklands as a Race Track and as a site for the development of the motor car. Again using concrete, its 352 feet (107.30 metres) long incline with an average gradient of 1:5 increasing to 1:4, was used to test motor cars, motor cycles and certain commercial vehicles. This value is again recognised with its inclusion in the Scheduled Monument designation.

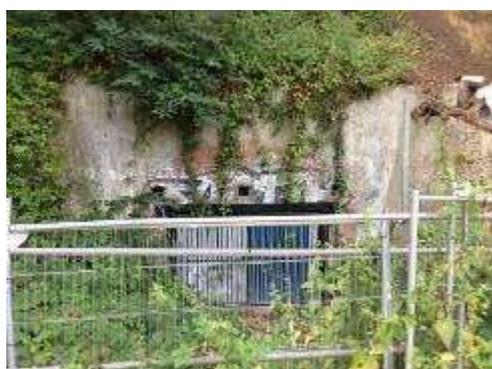
Fig 5.1 – North side of Competitors' Tunnel during construction works at Railton Place
(Radley House Partnership)

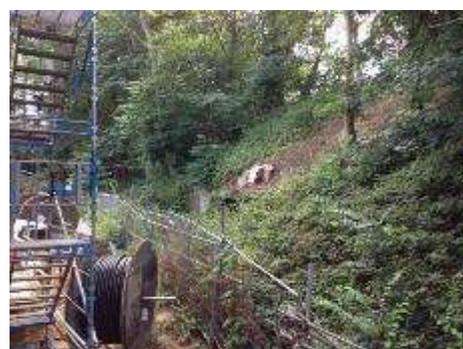
- 5.2.3 At the time of the site appraisal, the extant sections of railings are badly damaged and distorted as a result of ground movements in the banking and a lack of maintenance/vegetation clearance over a long period of time. As a condition of the Scheduled Monument Consent, new railings have been erected to reinstate this significant boundary.

Fig 5.2 – Support banking to the Members' Banking overgrown with vegetation.
(Radley House Partnership)

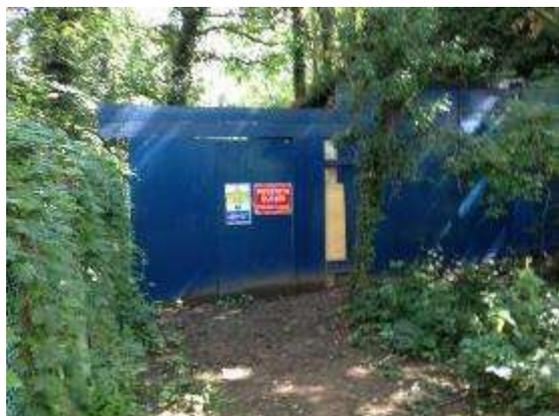
- 5.2.5 At the time of carrying out the site appraisal, access and amenity was understandably restricted and limited as an active construction site. However, it is acknowledged that a public right of way runs along the north-west boundary of the area, which gives access to the River Wey and routes beyond at the south-west and through to Weybridge in the north.

Fig 5.3 – The west end of the public right of way, blocked and diverted during the construction works at Railton Place
(Radley House Partnership)

- 5.2.6 On completion of the construction works, the public right of way was reopened. The amenity and historic understanding of the area may be limited as a result of the new development obscuring much of the support banking and Shell Way Tunnel. However, another requirement of the planning permission and Scheduled Monument Consent, has ensured that an interpretation panel has been added adjacent to the Shell Way Tunnel access to provide appropriate historical information about Brooklands and the use of the tunnel.

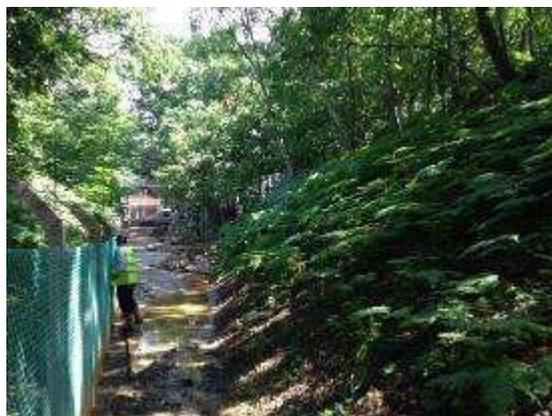
Fig 5.4 – The public right of way leading to the River Wey, pooling water and boggy ground evident.
(Radley House Partnership)

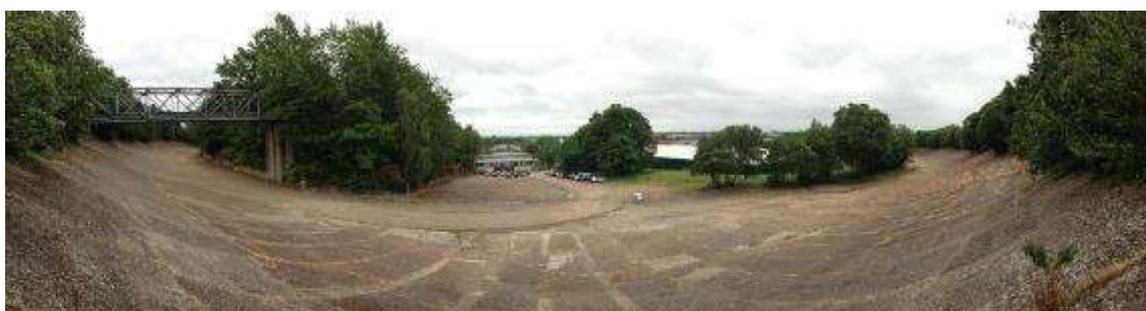
Fig 5.5 – Panoramic view of the Members' Banking with the Finishing Straight in the centre.
(Radley House Partnership)

- 5.3.4 What remains of this curved section of concrete race track, as elsewhere, clearly demonstrates how the surface was originally cast in-situ in approximately 10' wide bays – a significant factor in the character of the race track. Inevitably many of the joints have opened up allowing weeds and grasses to become established, however, a cyclical maintenance regime is in place to monitor and treat the weed growth between the joints and moss across the surface of the track so that it can be appropriately managed to reduce the risk of damage. The occasional limited use of the track during motoring events and demonstrations also helps to address the weed growth, although adversely the risk of surface degradation is increased as a result of the wear and tear.

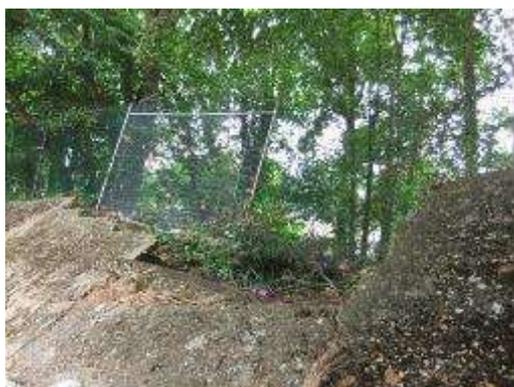
- 5.3.5 The upper track edges and support banking are also at risk of damage from vegetation. As is noted with the Brooklands Community Park (see 5.8 below), the flora and trees that have become

established on the support banking make a significant contribution to the character and atmosphere of the Conservation Area, as well as providing a visual and acoustic buffer between Brooklands and the residential areas to the north. However, where previously unmanaged trees have become established close to the track edge, damage has been caused to the concrete track surface with localised areas of cracking and collapse. The ongoing cyclical maintenance regime should continue to monitor all tree growth close to the track edge, as well as any potential undermining as the result of burrowing animals, to ensure that any issues are dealt with before further damage can occur to the race track.

Fig 5.6 – Partial collapse and undermining to the top edge of the race track

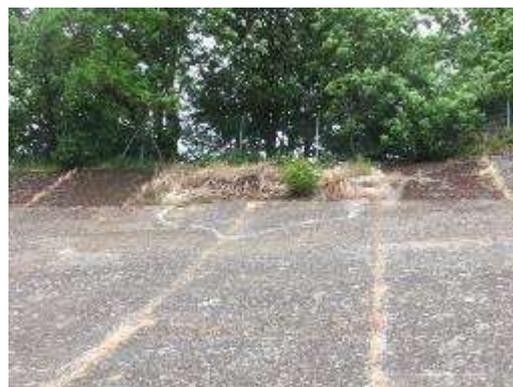
Fig 5.7– Vegetation and weed growth becoming established to areas of track degradation.

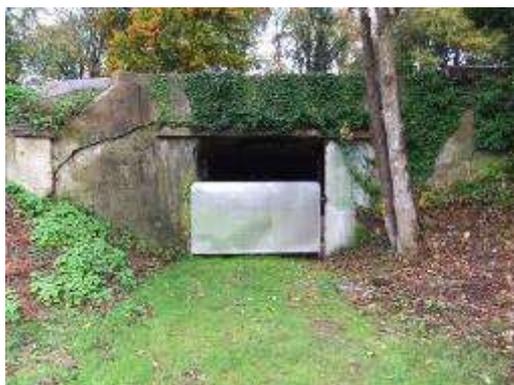
5.3.7 The southern entrance to the Shell Way tunnel has experienced significant structural movement, while internally a history of long-term water penetration is evident with corrosion to the World War Two reinforcing metalwork as well as staining and damage to the concrete ceiling and wall surfaces. Ongoing water penetration is also evident towards the southern end of the pedestrian tunnels. The structural movement should continue to be monitored and consideration given to discrete strengthening works if found necessary, especially if the opportunity arises to bring it back into greater public use as a potential exhibition area. Although much of surface water is likely to run off and away from the track surface along its lower edge, water penetration to the tunnels is unfortunately unavoidable as a consequence of the race track's construction and numerous joints between concrete bays. Typically, major intervention works would be required to introduce some form of waterproofing layer, which in this situation would be greatly detrimental to both the significance and character of this heritage asset. Therefore all gullies and drains should be kept clear as part of routine maintenance works and large open joints sympathetically repaired to minimise further damage – while internally, the spaces should be monitored and consideration given to improving any internal drainage to ensure that excess water is routed away from the race track and its associated structures.

Fig 5.8 – Southern entrance to the Competitors' Tunnel, structural movement evident on left hand side.
(Radley House Partnership)

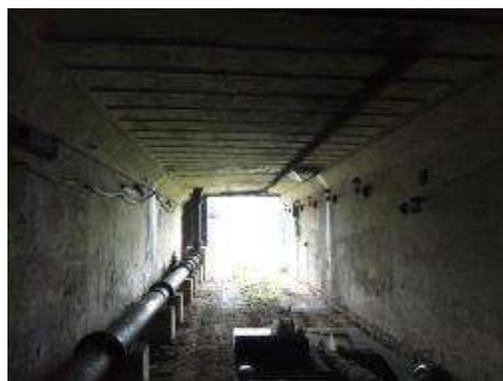
Fig 5.9 – World War 2 alterations to interior of the Competitors' Tunnel evident to the lowering and reinforcement of the ceiling.
(Radley House Partnership)

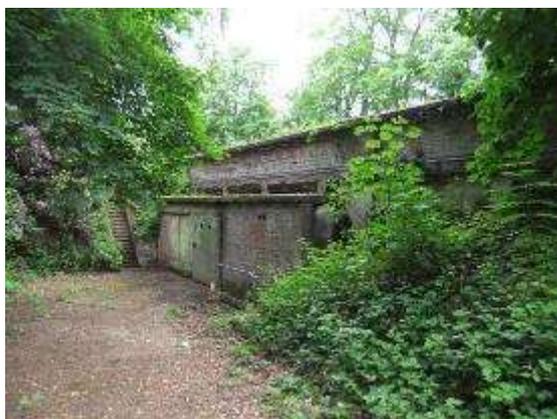
Fig 5.10– Southern entrance to the Pedestrian Tunnel, with World War 2 alterations to the exterior.
(Radley House Partnership)

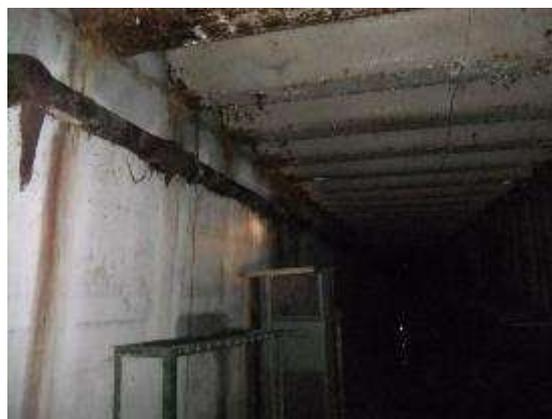
Fig 5.11 – Internal view of one of the three corridors within the Pedestrian tunnel.
(Radley House Partnership)

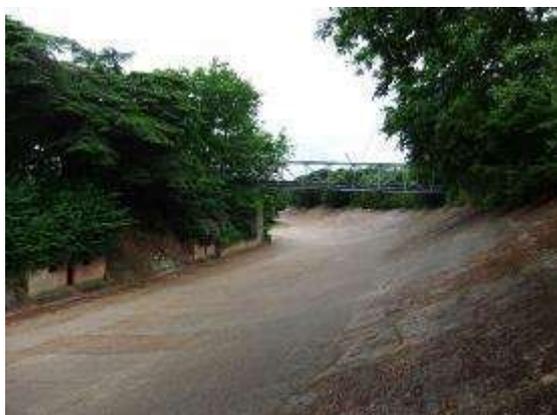
Fig 5.12 – Members' Banking to the north-east side of Members' Hill. Air raid shelters built into the Hill and the scar in the track surface showing the late-twentieth century repairs in the location of the former hangar.

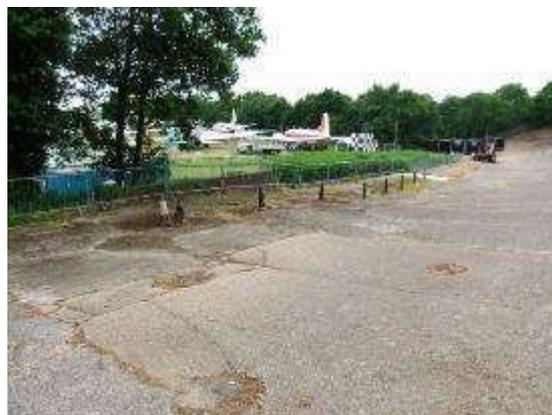
Fig 5.13 – Alterations and repairs to the inside track edge over the southern entrance to the Competitors' Tunnel.

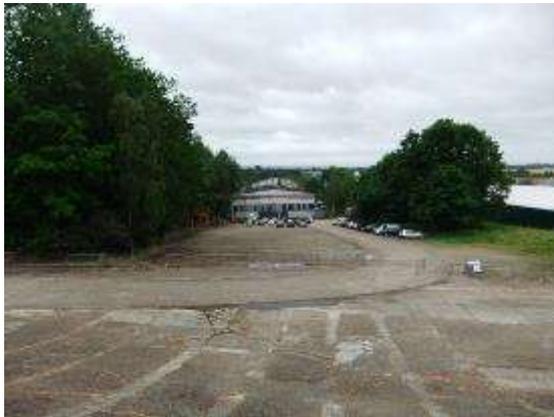
- 5.3.12 Again constructed with in-situ concrete bays, the different surface finishes along its length indicate different phases of repair. Sections of the original gully and kerbing also remain along its eastern edge. There are signs of varying degrees of surface degradation to the track surface and as noted with the Members' Banking, scars associated with its war-time and post-war industrial use and alteration are also clear to see. Principally through the continuation of the concrete road cut and cast through the west side of the former race track surface linking hangars T194 and T2020 (see 5.3.9 above). A significant number of other factory-related smaller structures were built towards the northern end of the Finishing Straight during the 1940-41 period. To the north of the Bellman hangar, on the east side of the former race track, a Boiler House, Sub-Station and Trailer Pump House were built – the concrete bases supporting the pipework between these building still remain. Another small storage building (later known as T190) was erected at the western edge of

Fig 5.14 – View down the Finishing Straight towards the Bellman hangar with the scar of the concrete post-war road, originally between hangars, in the foreground.
(Radley House Partnership)

- 5.3.13 With free space at a premium within the museum site, the extant section of the Finishing Straight is now typically used for vehicle parking (mainly by museum staff and volunteers) and lightweight equipment storage so much of the track surface and its associated features can become hidden from visitors. As elsewhere, there is opportunity to overcome this with the inclusion of interpretation panels located at key vantage points to help illustrate the purpose and its later evolution in context.

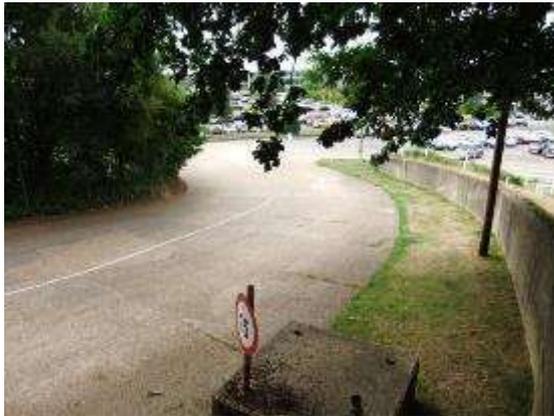
- 5.3.15 Three of the sections of this 1937 road racing circuit: Test Hill Hairpin, Dunlop's Delight and Banking Bend are the only remains of the Campbell Circuit within the museum site. Again constructed in a series of concrete bays, these sections of track formed the eastern end of this later circuit, which allowed the course to rise up the southern side of Members' Hill and connect with the higher Members' Banking beyond.

- 5.3.16 Fortunately, as well as the track surface itself, many of the original features and details still survive along these three sections of the former Campbell Circuit. These include: sections of the in-situ cast concrete retaining walls around the north side of the Test Hill Hairpin and north-east side of Dunlop's Delight – the latter having three openings with steps beyond which would originally have provided access to the spectator enclosures on Members' Hill; sections of low-level in-situ cast concrete kerbing (including metal columns and formwork encased within) along the south-western edge of the track surface; and the remains of the pre-cast drainage gully at the southern end of Dunlop's Delight and the inner radius of the Banking Bend.

Fig 5.16 – Campbell circuit – Test Hill Hairpin

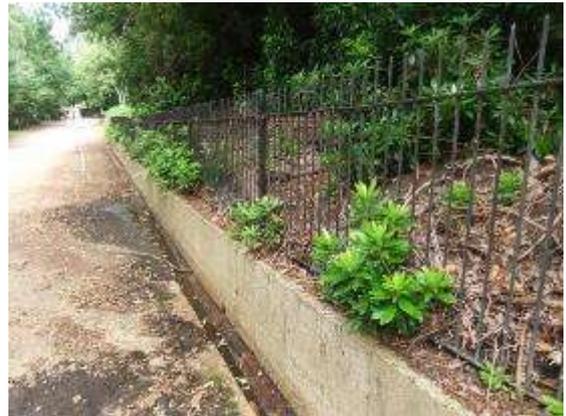
Fig 5.17 – original boundary treatments along the western edge of Dunlop’s Delight, part of the Campbell Circuit.

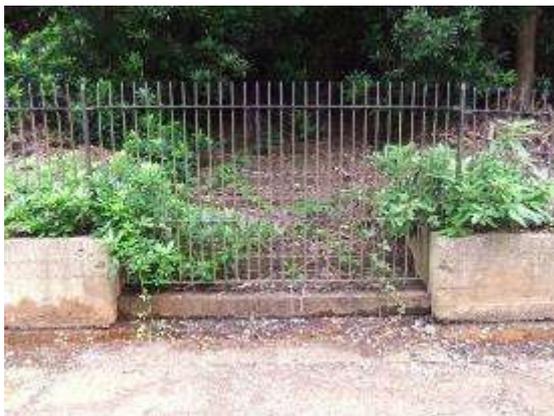
Fig 5.18 – One of the stepped entrances leading into the former spectator enclosures off Dunlop’s Delight.

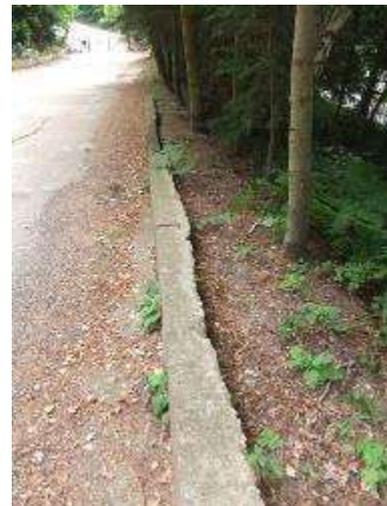
Fig 5.19 – Low-level in-situ cast concrete kerbing to the south-western edge of Dunlop’s Delight.

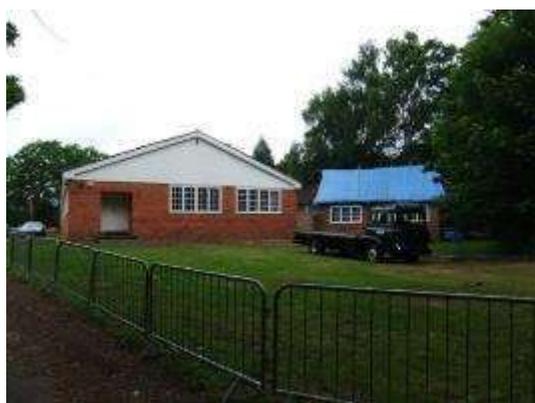
- 5.3.20 The earliest surviving structure here is the former Members' Hill Restaurant, a complex of buildings which fell into disrepair and were 'at risk' for a number of years, partly as a result of the difficulty in finding a viable use in its somewhat isolated location. Fortunately this risk has now been removed through its current tenant (motor vehicle restoration specialists), who is in the process of bringing the buildings back into full use while carrying out an ongoing phased programme of sympathetic repairs. There is also a long-term aim of allowing visitors access to limited parts of the buildings so that they are able to gain a fuller understanding of the buildings and also see traditional vehicle manufacturing/repair techniques being carried out in the context of historic cars. Such a sympathetic approach should continue to be encouraged to aid the viability of the buildings' future, although access to and around them will need to be properly managed to avoid the risk of damage to the landscaping through increased footfall (see 5.3.22 below).

Fig 5.20 – Members' Hill Restaurant, undergoing a phased programme of restoration work.

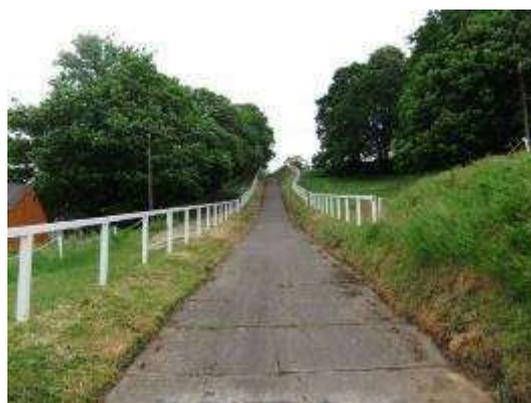
Fig 5.21 – Looking up the Test Hill, with areas of worn grass up the left hand side as a result of visitor impact.

- 5.3.21 The Test Hill itself and its exit route are the only track surfaces which were built on Members' Hill. Cut into the 'natural' contours of the Hill, the concrete surface is laid in a series of bays across three increasingly steeper inclines, before levelling out at the top of the Hill where a tarmac surface gently falls back down around to the east before joining with the Outer Circuit below. As elsewhere with other concrete track surfaces, some of the bays are fractured and at further risk from

- 5.3.22 While the museum requires a regular flow of visitors to ensure its survival, it also has to consider their access and movement around the site – especially with respect to the grassed areas on Members' Hill. With no hard-surfacing alongside the Test Hill surface itself, the grass inevitably becomes badly worn exposing the earth and tree roots as a result of the visitor footfall – which in turn can lead to further damage with routes being worn into the surface. Consideration should be given to how this can be managed in the long-term, so that visitors are able to fully and safely access the Hill and its assets, without causing long-term harm to surviving features. This may include adding grass reinforcement to areas likely to suffer the greatest degree of wear, so that the green and natural appearance of the Hill can be maintained, without it being scarred by excessive wear or the addition of an inappropriate hard surface instead.

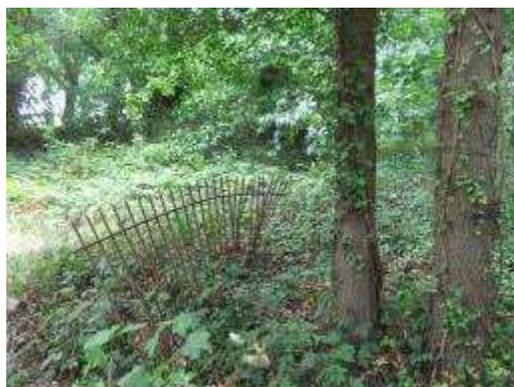
Fig 5.22 – Extant distorted sections of railings that originally separated different spectator enclosures on Members' Hill.

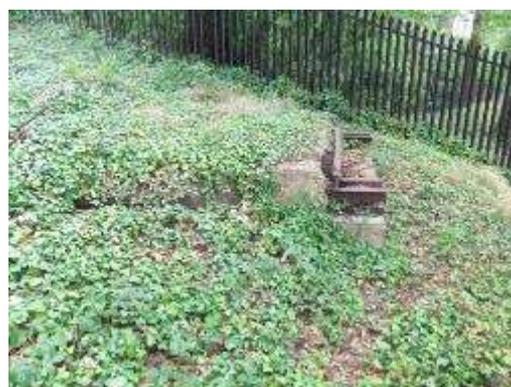
Fig 5.23 – The remains of the footbridge that allowed access from Members' Hill, over the Campbell Circuit, to the spectator areas beyond.

- 5.3.23 In addition to the buildings and Test Hill, which can be clearly seen and appreciated in their setting, elsewhere on the south side of Members' Hill other surviving features from the pre-1939 period of Brooklands can be found. Many of these remains have now become obscured by vegetation or are overlooked by visitors due to their lack of context and understanding. These features range from sections of old metal railings which would once have divided the Hill into its different spectator enclosures, to concrete bases/footings from former bridges which originally allowed spectators access over the Campbell Circuit to the south and also allowed spectators to move down the side of the Test Hill and across it at the same time. As these features can be overlooked by the uninformed visitor, their understanding and existence could be greatly increased through reference to them in the Museum Guidebook(s) and/or the addition of interpretation panel(s) on Members' Hill to illustrate the former layout and original context of the surviving features. It should also be possible to remove some of the undergrowth and maintain these features free from vegetation in the future.

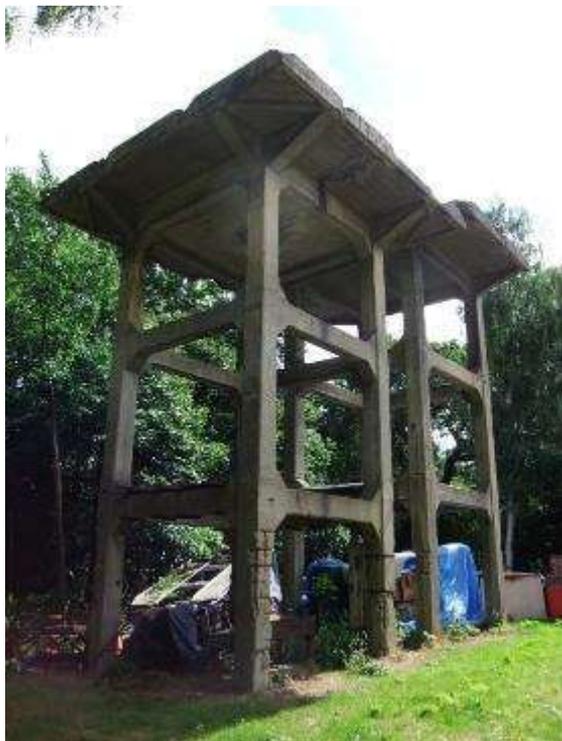
- 5.3.24 With the outbreak of World War Two, Members' Hill was an ideal location for the addition of some of the necessary measures to help defend and protect aircraft manufacture at Brooklands. This therefore led to the construction of the reinforced concrete Bofors Anti-Aircraft Gun Tower, to the

north-east of the former restaurant buildings. Now obscured by trees, it is not readily visible unless you are actually on the top of the Hill and as with other war-time concrete, it has suffered as a result of the reinforcement corroding – making it unsafe to walk around or below. In March 2012 the museum commissioned a specialist survey of the structure to assess its condition and consider options for its repair. As funds become available, consideration should be given to the long-term repair of this structure – in the short-term further information in the Guidebook could be made available along with an interpretation panel at the top of the Hill.

Fig 5.24 – Bofors Anti-Aircraft Gun and Sighting Tower

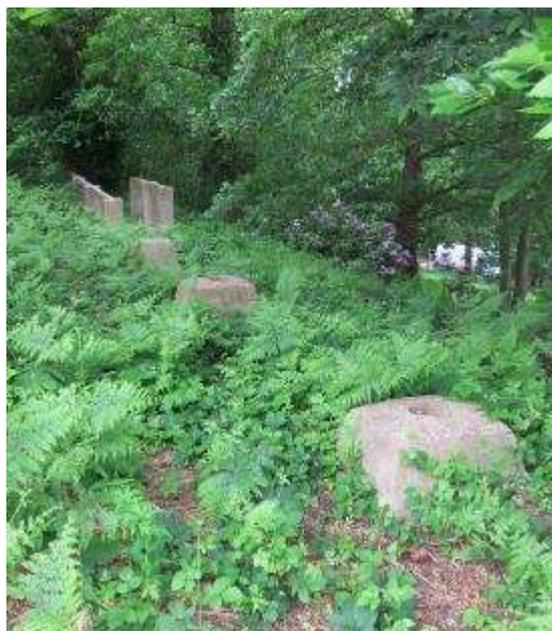
Fig 5.25 – Pre-cast concrete frames and bases on the south side of Members' Hill obscured by vegetation.

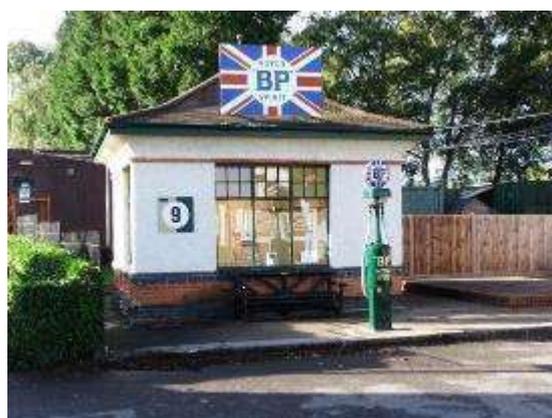
Fig 5.27 – BP Petrol Pagoda, on completion of recent restoration works.
(Radley House Partnership)

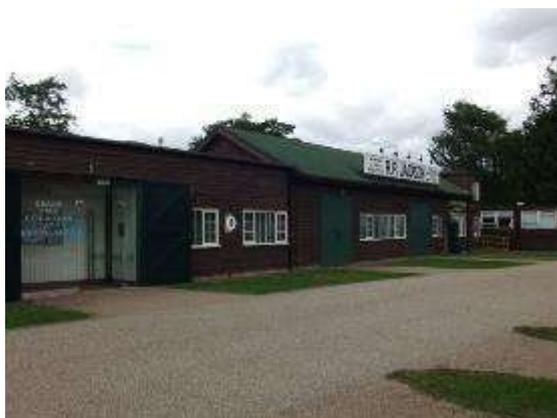
- 5.3.29 For the early buildings, which relate to the motor racing period at Brooklands, a range of architectural styles and materials was used, reflective of their type and period of construction. The former BARC Clubhouse and the later fuel supply buildings being predominantly of traditional brick construction, while the workshop buildings were timber-framed and timber-clad. The robustness of masonry construction is typically better able to withstand the effects of weather, use and alteration compared to timber, which is replaced on a cyclical basis. This can be clearly seen with both the Jackson Shed and the Racing Lock-Ups, where the replacement timbers are cupping and moving, leaving open joints between, potentially putting the structure within at risk. Also with the Jackson Shed, it would appear that inappropriate 'modern' T&G boards have been used with a minimal lap and minimal fixings, which are noticeably shrinking and cupping, instead of a traditional deeper shiplap board which would have had a greater lap and greater durability.

Fig 5.28 – The Jackson Shed on the west side of the Paddock.

- 5.3.30 However well-intentioned repair proposals may be, often the use of an inappropriate method or type of material can be detrimental to the building in the long-term both in terms of its aesthetics and its structural integrity – this can apply to masonry and timber buildings. Therefore when considering any works of repair or alteration to any such asset, consideration must be given to the value and importance of the building, to ensure that any future work is sympathetic. This Plan and its associated documents will help to provide the understanding required to achieve this and also assist the volunteers and contractors who greatly contribute to the viability and success of the site.

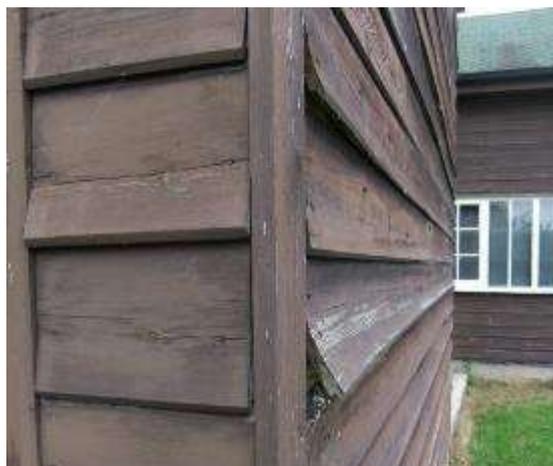
Fig 5.29 – Examples of cupping and distortion to inappropriate replacement weatherboarding on the west side of the Jackson Shed.

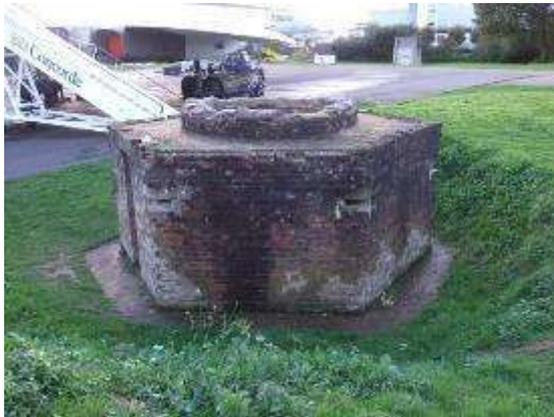
- 5.3.31 The war-time additions to the site, as with the early motoring structures, again reflect both robust and lightweight methods of construction with the Pill Box and T222 both being of masonry construction whereas the Bellman hangar is a 'lightweight' construction in comparison, with its demountable steel frame and lightweight cladding sheets. Although the Pill Box and T222 are not accessible internally to visitors, they are important in terms of the overall site context clearly demonstrating the war-time connections, which the Bellman hangar more readily achieves through its exhibits and display information contained within. There is an opportunity to improve this understanding and evolution of the site during World War Two, through additional guidance information and/or interpretation panels for these two assets.

Fig 5.30 – World War 2 Pill Box – locally listed.

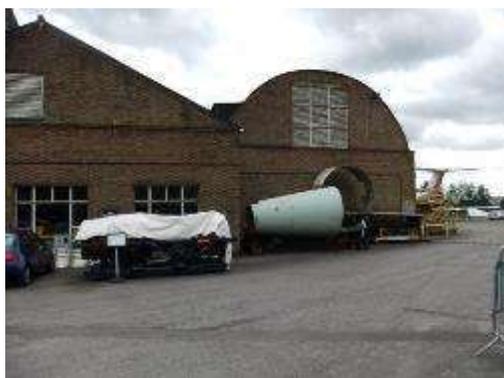
- 5.3.34 At the time of carrying out the appraisal, the Stratosphere Chamber was undergoing a series of major repairs, predominantly focussing on the equipment, controls and associated exhibits within – these works were successfully completed and the building reopened on 13th March 2014. However, similar to the Bellman hangar, the external envelope comprises of a steel frame clad with profiled sheets – which in this case are cement-based (which may contain asbestos), and are known to be vulnerable on the roof with a history of leaks experienced. Therefore although it is of benefit for visitors to enhance the internal areas, thought should also be given to overhauling and possibly replacing the external roof cladding to provide a weathertight structure. In 2014 the Balloon Hangar and Supersonic Wind Tunnel were the subject of major restoration (both buildings being completely reclad and insulated with modern materials) with a new 4D Theatre visitor attraction installed in the Balloon Hangar and the Supersonic Wind Tunnel area being renamed ‘The Vickers Building’ and converted complete with kitchen and toilets for use as flexible space suitable for corporate/private events and temporary exhibitions. Completed in just over six months, the rejuvenated buildings were officially reopened on 2nd September 2014.

Fig 5.32 – The Balloon Hangar (right hand side) and the Supersonic Wind Tunnel (left hand side), viewed from the north, which are joined to the Stratosphere Chamber (off the left hand side of the photograph).

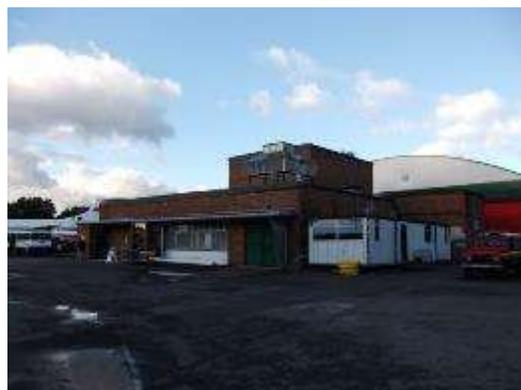
- 5.3.35 The Acoustics Laboratory retains a number of its original features, such as the heavy sound-proofed doors between the rooms. However, the acoustic linings to these rooms have been lost as the spaces have been converted to store archive materials and house the Concorde simulator and a vehicle workshop. Change is inescapable, especially with museums which need to evolve and grow to keep attracting visitors. However, there is a risk that visitors could miss out on learning about the original purpose of this building, with the current interpretation information being positioned discretely. Thought should be given to enhancing this information further, allowing visitors to learn more about the building through the Museum Guidebook(s) and interpretation panel(s) within the building itself, this can then also be used to enhance and strengthen the Brooklands connection with Concorde and its associated exhibits.

Fig 5.33 – The Acoustics Laboratory viewed from the south-east.

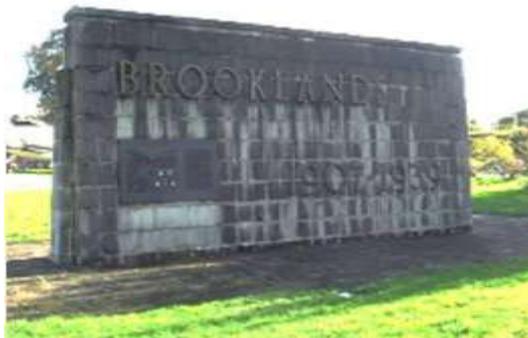
- 5.3.39 The Brooklands Memorial, first erected in 1957, was originally located on the north-west side of the former airfield, facing the railway line beyond. Commissioned by Vickers-Armstrongs, it was erected to commemorate the 50th anniversary of the site. However, to make way for following the construction of the Mercedes-Benz World building, it was relocated in 2003 to its current location on the museum site (but with the same orientation). It is constructed from panels of 'white spar stone' over a solid masonry core and surrounded by an area of concrete paving. The impressive original bronze plaque and lettering were stolen in the 1960s and only the plaque was later recovered – this is now displayed inside the former BARC Clubhouse main entrance foyer with a

replica made in composite materials now fixed to the Memorial. The lettering is also replicated in the same material.

Fig 5.34 – The Brooklands Memorial
(Radley House Partnership)

- 5.3.40 Unfortunately, the principal north-west elevation can only now be seen from within the site, as trees and vegetation along the riverbank obscure the view of the memorial from elsewhere outside the site – consideration could be given to clearing and pruning some of these trees to allow the monument to be viewed from the west side of the river. The reconstituted stone blocks facing the memorial show some discolouration and corner sections are beginning to fracture and break away from the remainder, possibly as a result of water/frost damage – these should be discreetly pinned to the structure and made good. Consideration should be given to cyclically monitoring the fabric of the memorial alongside the monitoring of the other built heritage assets on the site.

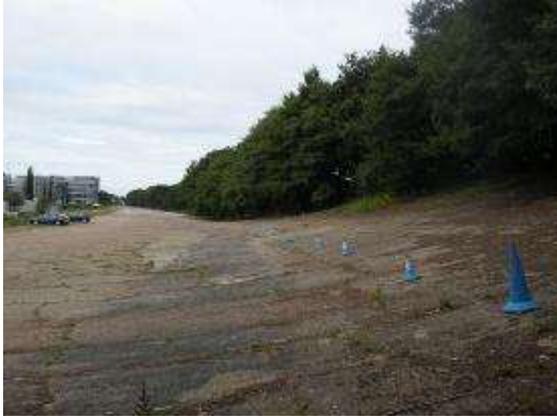
- 5.4.2 Originally linking the Members' Banking, via the Hennebique Bridge over the River Wey, at the north end of the Outer Circuit with the Byfleet Banking at the southern end, this long straight is generally flat apart from its northern end where it begins to slowly rake up towards its outer edge to line up with the Members' Banking. Now wholly contained within Mercedes-Benz World, the majority of this section of the race track remains although scarred by later uses and occupation associated with the aircraft factories – and at the time of writing this Plan, trial works were beginning to lay a modern replica track surface over the top of the original in an attempt to protect the asset while providing a new useable durable surface for the future.

Fig 5.36 - The flat Railway Straight (in the distance) gradually rising up to meet with Members' Banking (behind).

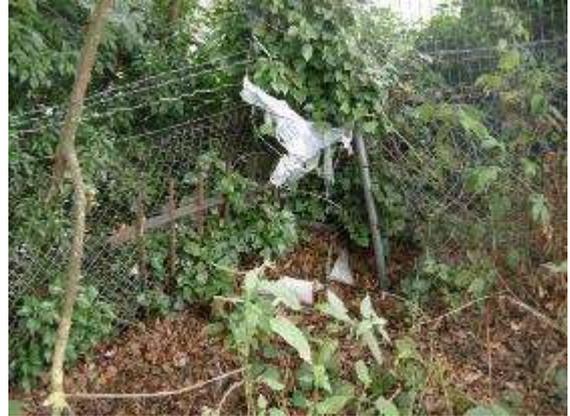
Fig 5.37 - Small length of the original 'Bayliss' iron boundary railings being subsumed by overgrowth and vegetation.

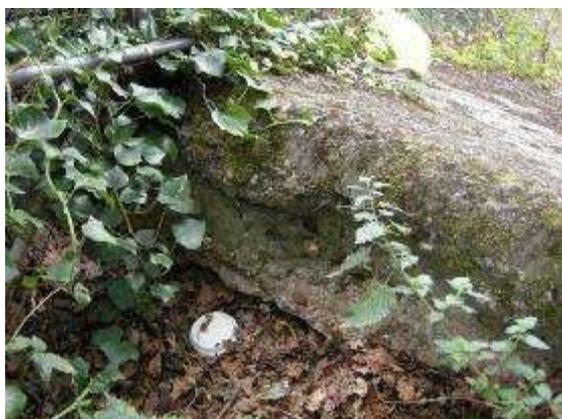
Fig 5.38 - Exposed top edge at the northern end of the Straight, demonstrating the construction build up and inclusion of expanded metal lath reinforcement (non-original) in between the layers.

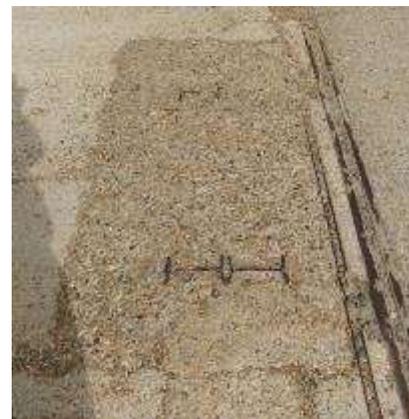
Fig 5.39- Remains of a Bellman hangar T184, including the metal channels for the sliding doors and metal columns now cut off flush with the raised concrete floor (laid over the former race track).

5.4.4 As briefly noted above, evidence of the later use of the track during World War Two and then by Vickers-Armstrongs and the post-war aircraft industry is clearly evident along this section of track. This is most notable in the location of a former Bellman hangar, where its raised concrete floor (laid over the former race track) and the metal channels for the sliding doors at its north and south ends are still evident. During Vickers-Armstrongs' ownership of the site, this hangar became the post-war 'Hammer Shop' (VA Reference T184) with a crane being located externally at its southern end and a series of 'Swarf Bins' and a Sub-station (VA Reference T186) built along its eastern edge – for which a number of the scars and repairs in the track are likely to relate. Further north, perpendicularly aligned with the former Vickers runway are a series of three diagonal scars running across the surface of the track – these identify the position of a series of large post-war sound deflectors. Associated with ground running engines on VC10s and other large aircraft being prepared for test flights.

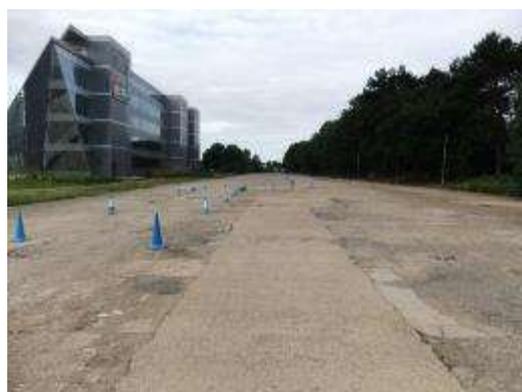
Fig 5.40 - Surface degradation and scars associated with Vickers-Armstrongs occupation in the track surface (including the likely location of the Hammer Shop crane above)

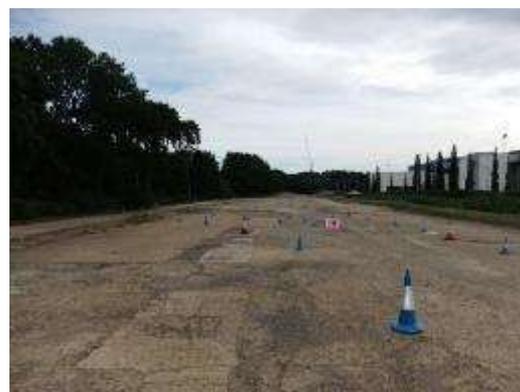
Fig 5.41 - Further surface degradation, patch repairs and scars of previous uses on the track towards the southern end of the Railway Straight.

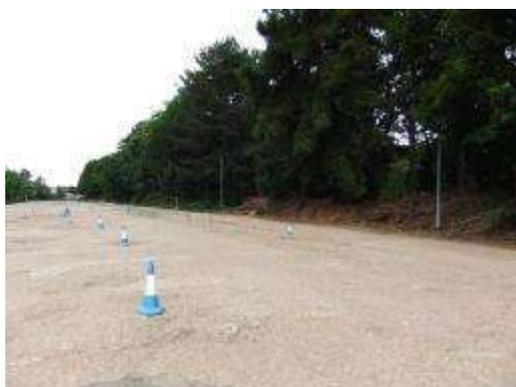
Fig 5.42 – Inappropriate modern lamp standards positioned close to the former track edge.
(Radley House Partnership)

- 5.4.5 Along its outer edge, towards the southern end of the track, are a series of modern lamp standards positioned close to the former track edge. These are understood to have only been temporary features associated with the Mercedes-Benz World development, when the contractors' site compound was based in this location. They have never been removed and continue to appear incongruous with the former race track – now redundant, these should be removed with care, along with any associated electrical services and the ground made good.

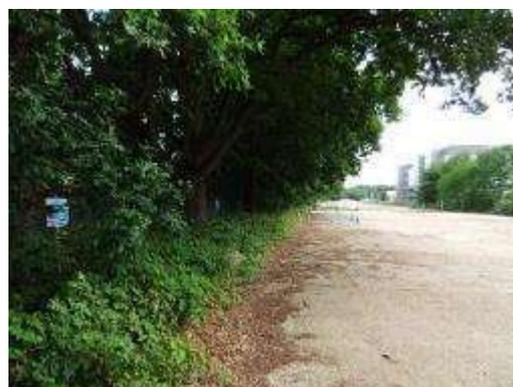
Fig 5.43 - Vegetation encroaching across the track obscuring and potentially destroying the original edge treatments and alignment.
(Radley House Partnership)

- 5.4.6 Both the inner and outer edges of the track, for much of the length of the Railway Straight have become lost as a result of the encroaching vegetation – with only a relatively small length of the inner kerbing and gully (now filled) remaining towards the northern end alongside the earth bund. Although weed growth between the bays of concrete is minimal – this is likely to be as a consequence of regular maintenance and the track being in relatively regular use for driver training. Much of the tree growth along this section of track forms a buffer to the railway line to the west – unlike other sections of the track, they are generally not against or close to the track edge so unlikely to cause damage in the short-term. However, they should be monitored and regularly maintained to ensure that there is not a long-term risk to the track as a result of root growth.

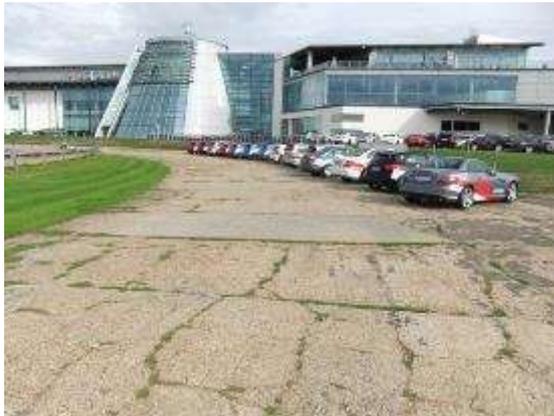
Fig 5.44 - Various degrees of surface degradation to the track, including some tarmac surfacing and modern patch repairs.
(Radley House Partnership)

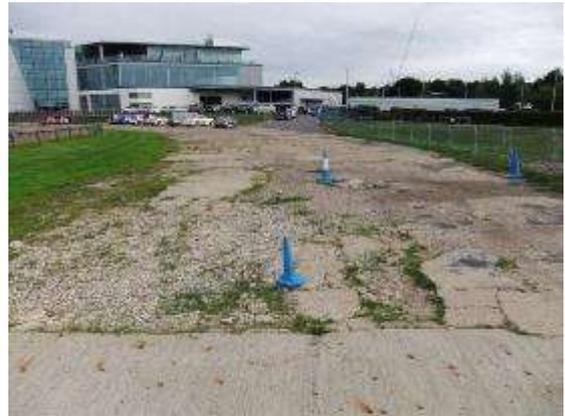
Fig 5.45 – Significant surface degradation to the northern end of the ‘Sahara Straight’. Inappropriate replacement concrete bay in the foreground.
(Radley House Partnership)

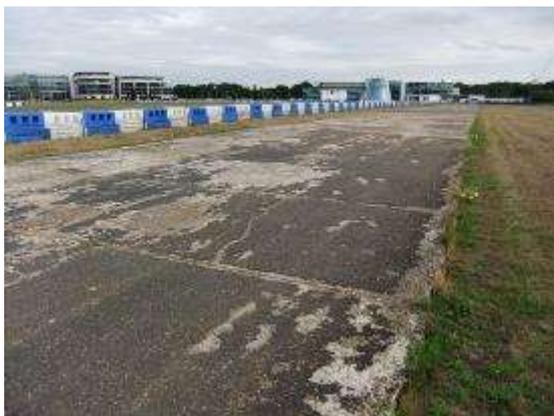
Fig 5.46 - Remains of tarmac top coat to surface of ‘Sahara Straight’ and erosion to track bays along their outer edges.
(Radley House Partnership)

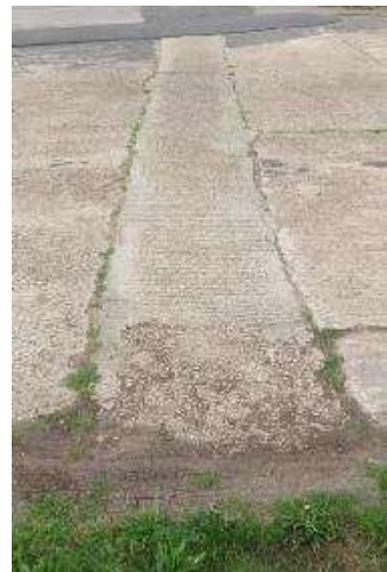
Fig 5.47 - Line of services cut through the track surface at ‘Howe’s Corner’, inappropriately filled and finished.
(Radley House Partnership)

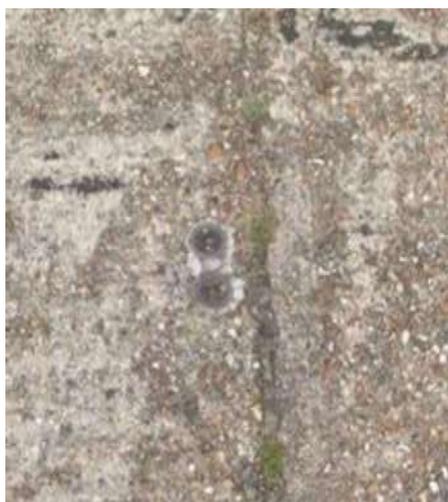
Fig 5.48 - Remains of metal posts (former barriers?) in track surface at southern end of the 'Sahara Straight'.

(Radley House Partnership)

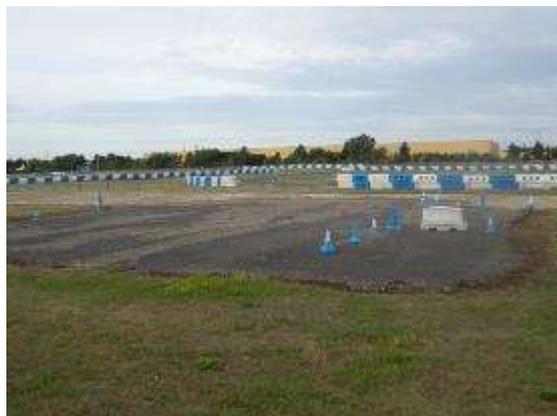
Fig 5.49 - Remains of the tarmac access road, off the 'Sahara Straight' which is understood to have provided access to Vickers-Armstrongs' 'Hydraulic Testing' building in the 1960s.
