BROOKLANDS AERODROME & MOTOR RACING CIRCUIT

CONSERVATION MANAGEMENT PLAN

Brooklands Heritage Partnership

October 2017

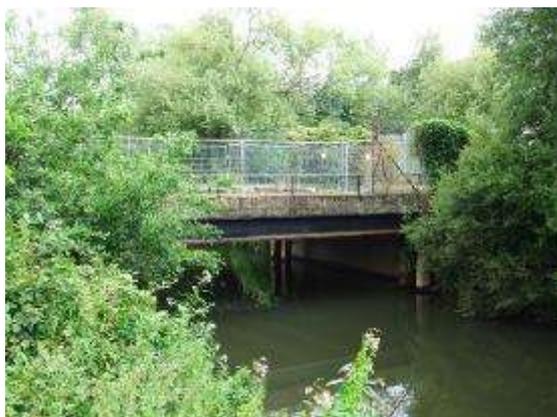
- 5.4.13 A 'Bailey' type bridge was believed to have been first constructed in this location circa 1937, possibly to have allowed vehicles and pedestrians to access the Campbell Circuit beyond. This current bridge was built presumably in late 1940 to enable Wellington and later Warwick aircraft (produced in the Bellman hangar (T202) on the Finishing Straight) to be towed across the river to the aerodrome. This bridge now provides a secondary 'private' means of access to the Brooklands Museum site and the movement of historic aircraft from the museum to the grass runway alongside the Sahara Straight.

Fig 5.50 - The Campbell Bridge, spanning the River Wey (viewed from the south-west).
(Radley House Partnership)

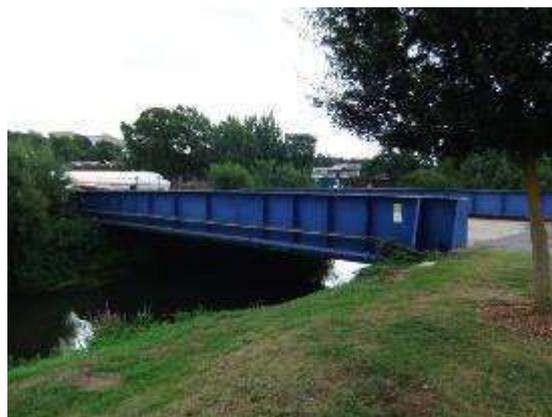
Fig 5.51 - The Vickers Bridge, spanning the River Wey (viewed from the north-west).
(Radley House Partnership)

- 5.4.14 Although no structural assessment has been made, the current structure appears to be in a sound condition. However, it was noted that on occasion heavy goods vehicles were left parked on the bridge and buses were using it as a turning point – instead of the designated area to the south next to the Museum car park. While such uses are unlikely to cause long-term damage to the bridge itself through loading, care should be taken to avoid any form of accidental damage from reversing vehicles to the structure itself. Consideration could be given to the addition of explanatory signs advising users and visitors of the importance and value of the bridge.

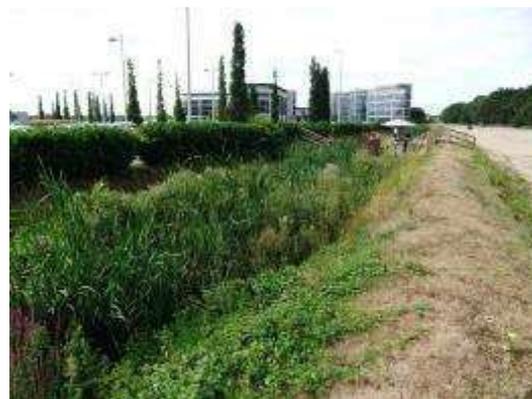
- 5.4.20 As part of the redevelopment of this area, a series of flood alleviation measures were required to address the impact of potential high water levels in the River Wey, at the northern end of the Brooklands site (the southern end being dealt with in the Community Park –see below). This takes the form of a deep open drainage gully connected to the river, to the north of the Vickers Bridge, which then runs alongside the inside edge of the Railway Straight before being diverted to the east into the 4x4 off-road driving course. This was designed to fill and flood, along with an area of the Community Park to the south, to protect the remaining developed areas of Brooklands.

Fig 5.53 - Wide drainage channel, constructed c.2005 alongside the eastern edge of the Railway Straight, as part of the flood alleviation measures for the northern end of the Brooklands site.

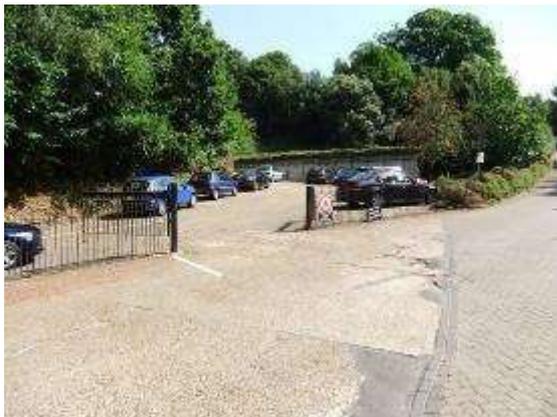
5.5.2 As with the other track sections, this consists of a series of concrete panels which also retain a profiled gully kerb to the north-west edge. The principal challenge here with the conservation of remaining sections of track, as identified previously, is the acknowledged and long-standing vulnerability of degrading surfaces and need to retain the originality and patina of age in terms of its aesthetical value. A key aspect of this is related to the ongoing maintenance through weed control and management of vegetation growth.

5.5.3 Further vulnerability and competing challenges exist through the effect of its current use as overflow staff parking for JTI UK Ltd.

Fig 5.54 – The remains of the 'Banking Bend' from the former Campbell Circuit, which once led round to the Members' Banking on the Outer Circuit. Now used as car parking by JTI UK staff.

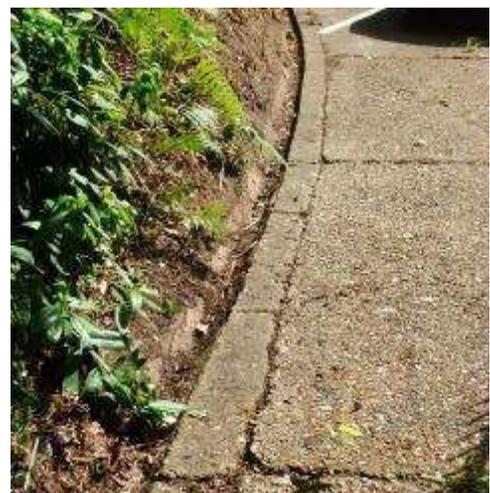
Fig 5.55 – The inner gully detail and concrete bays forming the surface of the Campbell Circuit Banking Bend.

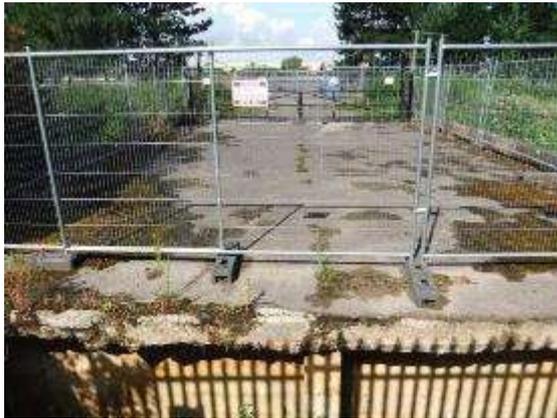
- 5.4.12 Beyond Howe's Corner, to the east, are the remains of the former Campbell Circuit Bridge (also known as Howe's Bridge and originally the Vickers Bridge (1932-37) and latterly the 'Five Tonne' Bridge) which crosses the River Wey to 'The Heights' development. There is no public access to this asset as it has now been fenced off for unspecified safety reasons – however, it is clear that the east side of the structure which would have connected with the river bank has been removed (this was noted in April 2011)¹⁷ and is yet to be reinstated and properly repaired. As part of the designated Scheduled Monument, every effort should be made to address the 'issue' that lead to its removal and so allow the missing section to be properly reinstated. Historic England is currently in discussion with the relevant landowners about repairing the bridge and its abutments.

Fig 5.57 – The remains of the former Campbell Circuit Bridge spanning the River Wey. A section of concrete surface to the east side was removed and temporary fencing erected c.2011.

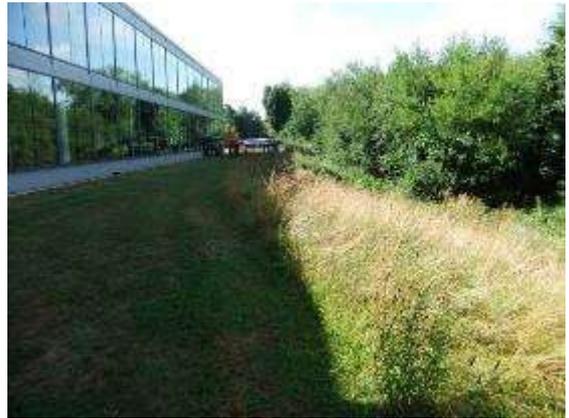
- 5.6.3 The southern section of this portion of Aerodrome Road was unfortunately lost in 2001/02 as a consequence of facilitating the new office development – for which four buildings were built in parallel with the road alignment. An apparent lack of understanding and appropriate routine maintenance of the landscaping associated with the development and more recent extensions to the office buildings on the west side of The Heights, has resulted in the condition and survival of the extant section being under threat.

Fig 5.58 – Location of the southern section of Aerodrome Road, removed 2001/02 as part of the redevelopment of the site.

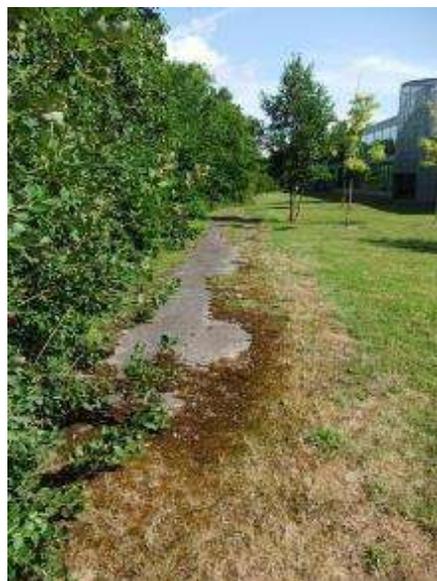
Fig 5.59 – Section of Aerodrome Road visible through the encroaching river-bank vegetation and moss/grass. Root growth from trees planted along the edge of the road, have the potential to damage both hidden and visible remains.

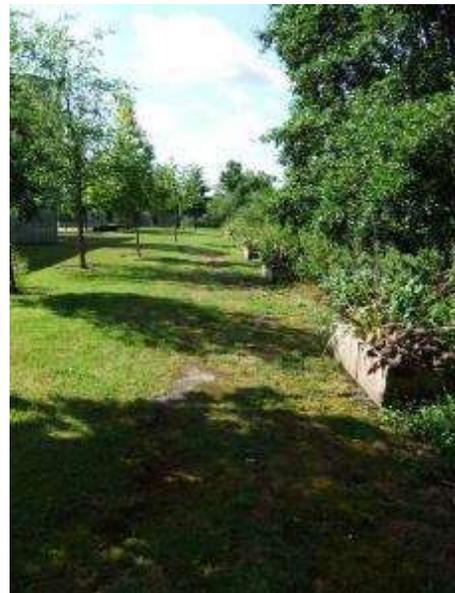
- 5.6.4 The apparent lack of understanding and consequent fear of damaging the surface of Aerodrome Road appear to have been a significant contributory factor in the minimal ground clearance and maintenance. This has unfortunately meant that an increasing area of the surface has become obscured – so much so that users of the neighbouring offices are unlikely to know it exists, let alone what significance it has to the rest of Brooklands. Landscaping works following the early development of the site, have led to a series of trees (including silver birches) being planted between the office buildings and the road. The justification for their planting is unclear, as privacy is not an issue and it was not a planning requirement. There is now the potential risk that as they mature and their root systems develop, they may damage the road. More recently, at the time of writing, works were being implemented for the extension of the northern of the four office buildings at its north-west corner, right up to the 'assumed' edge of the Road, following the granting of necessary permissions.

Fig 5.60 – Further sections of the road surface visible through the vegetation. Changes in levels in the grassed areas are also distinguishable, suggesting the possible edge of the roadway. As well as the trees along its eastern edge, timber planters have been laid across its western edge.

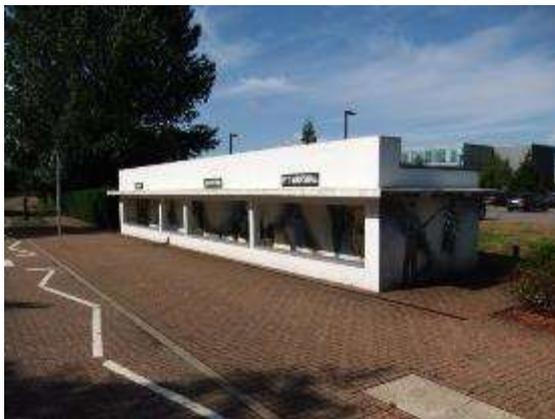
- 5.6.6 This now stands somewhat isolated within 'The Heights' development, alongside the principal access route into the site. Significantly shorter than the original in-situ concrete structure, which survived until 1989, only 3½ 'bays' of the original structure now remain. Furthermore, external ground levels have been raised; concrete blockwork has been used to infill former openings and construct a central spine wall to create a storage space which runs the full length of the 'building'. At the time of writing the Plan, the structure is being used by the grounds maintenance team for The Heights as a chemical and tool store.

Fig 5.61 – The remains of the Campbell Circuit Pits, viewed from the north-east.

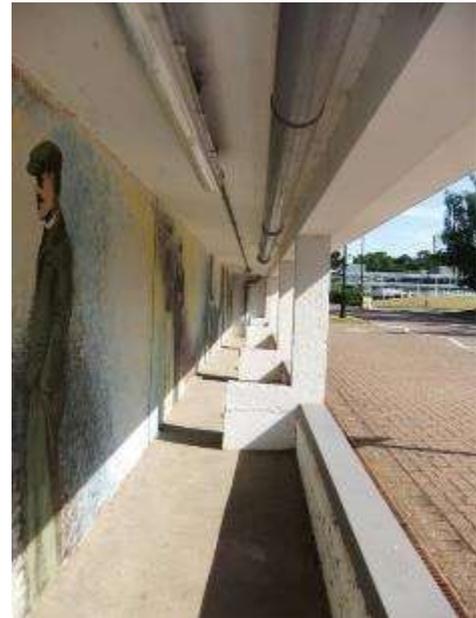
Fig 5.62 – Raised floor levels evident along with remains of former pit divisions and enclosures. 'Modern' in-fill wall (left hand side) decorated with motor racing mural.

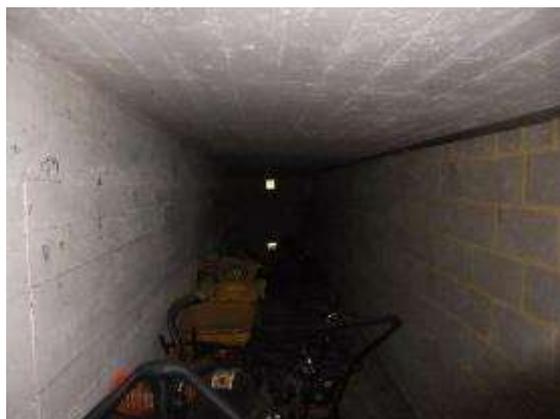
Fig 5.63 – Internal space now being used for storage. Original in-situ cast concrete wall (left hand side) and ceiling clearly evident, with later ‘modern’ blockwork in-fill wall on right hand side.

- Fig. 5.63 Internal space now being used for storage. Original in-situ cast concrete wall (left hand side) and ceiling clearly evident, with later 'modern' blockwork in-fill wall on right hand side

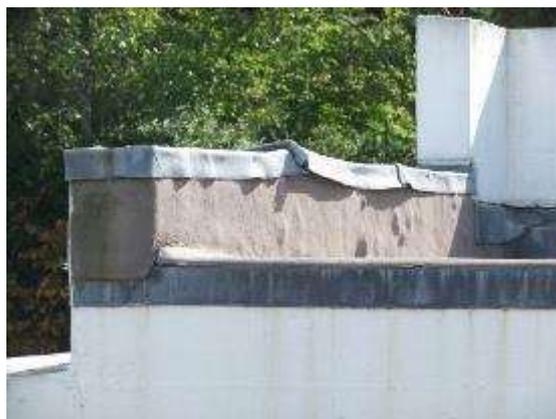
Fig 5.64 – Lead coping to north parapet appears to have been tampered with.

- Fig. 5.64 Lead coping to north parapet appears to have been tampered with
- Fig. 5.65 The remains of the former Campbell Pits isolated within the modern landscaping and access road for The Heights

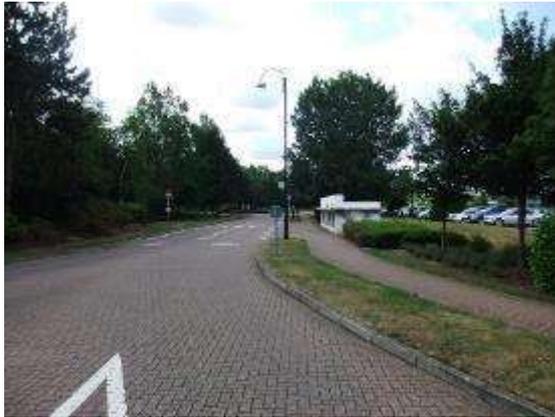
Fig 5.65 – The remains of the former Campbell Pits isolated within the modern landscaping and access road for The Heights.

- 5.6.11 Accessed from the private road Wellington Way, the extant features from the early history of Brooklands are no longer within or readily visible from the public domain. The extant sections of Aerodrome Road are hidden by both the new office buildings and the riverside vegetation and even though the former Campbell Circuit Pits structure is located on the main road into The Heights, visitors and users of the site are more likely to drive past on their way to or from work without properly acknowledging the building.
- 5.6.12 In the context of Brooklands’ heritage, as with some of the other characterisation areas, the amenity of ‘The Heights’ is limited. When physically moving about the area this is difficult to

interpret without prior knowledge – even for the former Campbell Circuit Pits. As discussed below, for the residential area, it is only through aerial assessments combined with knowledge of the planning considerations for the redevelopment, that it becomes apparent why the central car parking has been laid out with a series of raised kerbed islands and associated Thuja trees and lamp standards. Running north-south through the area, these have been deliberately aligned with the edges of the former Finishing Straight, with no buildings being permitted to encroach onto this area.

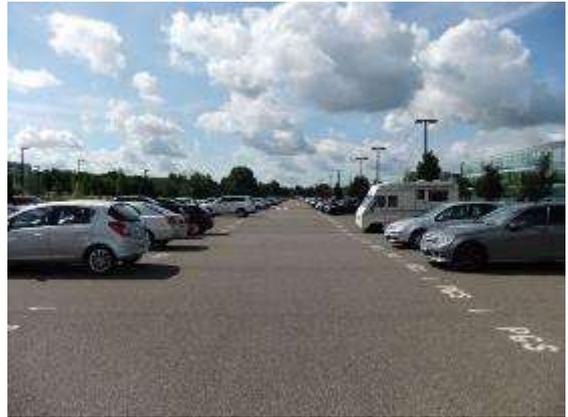
Fig 5.66 – Central car parking area aligned with the former race track Finishing Straight. Without context or interpretation panels this is not readily apparent.

- Fig. 5.66 Central car parking area aligned with the former race track Finishing Straight. Without context or interpretation panels this is not readily apparent

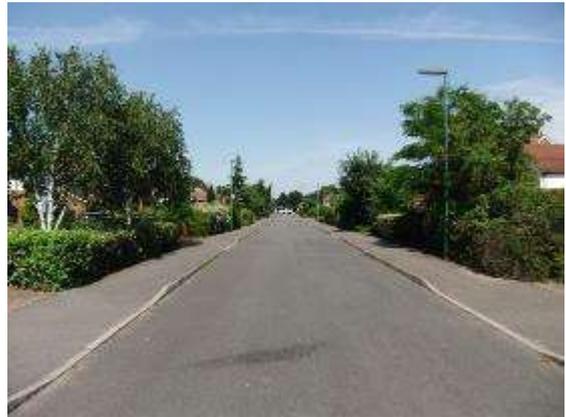
Fig 5.69 – Staniland Drive, looking north, which is loosely aligned along the former Finishing Straight of the Outer Circuit. However, without context or interpretation panels this is not apparent.

- 5.7.7 The amenity of this area could be greatly improved with the addition of (properly considered and designed) interpretation panels located at either end of Staniland Drive. These could be used to simply yet effectively illustrate the alignment of the current road in the context of the Brooklands Circuit as well as providing historical information to how this area evolved with the aviation industry. Furthermore, as suggested elsewhere, consideration could be given to giving a visual emphasis to areas which are aligned to sections of the former race track – either by a change of colour in tarmacadam to the affected areas or metal studs inserted into the surfaces to distinguish the track edges (with interpretation panels again used to identify and explain their significance and context of the track).

- Fig. 5.69 Staniland Drive, looking north, which is loosely aligned along the former Finishing Straight of the Outer Circuit. However, without context or interpretation panels this is not apparent

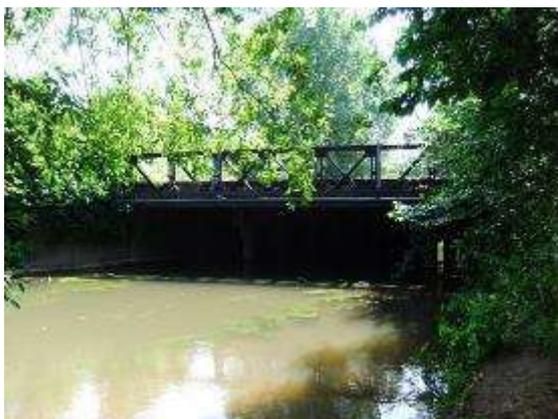
Fig 5.71 - Cobham Bridge (1933) spanning the River Wey.
(Radley House Partnership)

- 5.8.2 This section of the concrete race track, which formed the south-east quadrant of the former Byfleet Banking curves through the eastern side of the site. Following a reduction in gradient, it terminates at its north end with the Cobham Bridge whereas the southern end retains its steep gradient and has been terminated as a result of the construction of the Vickers runway (discussed further below). Along its outer boundary (east side) much of the original 'Bayliss' iron railings remain along the bottom edge of the earth banking. Its post-1939 can be seen with the scars left on the surface of the track by former buildings and structures mostly of war-time origin. The most noticeable towards its northern end where the raised rectilinear base of a former Incinerator (VA reference T371) can still clearly be seen, as well as the remains of metal columns cast into the surface of the track.

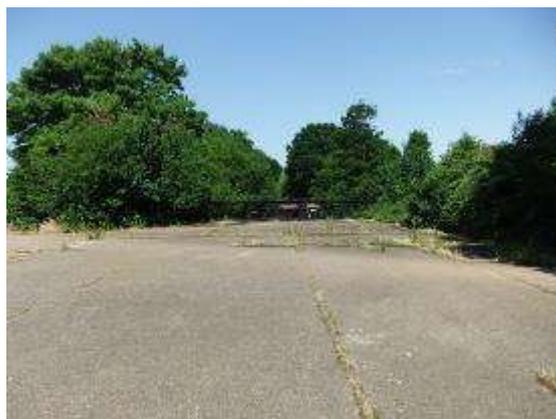
Fig 5.72 - Race track surface laid over the Cobham Bridge.
(Radley House Partnership)

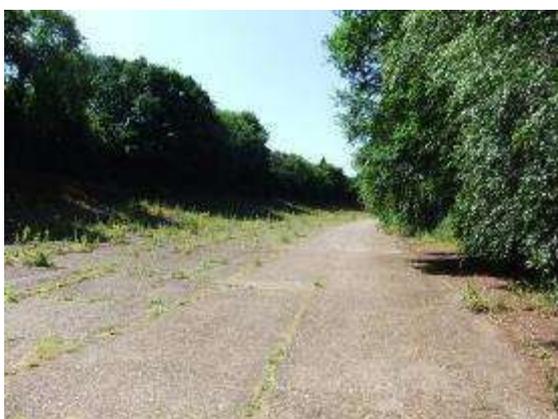
- 5.8.3 The long curving section of track clearly shows how the sectional concrete track surface was originally laid with its regular arrangement of bays, typically measuring 10' wide (3m). The exposed and damaged sections of the concrete along its top edge as well as at its southern termination (where areas of the track are no longer supported by the earth banking), further illustrate the overall thickness of the track (14"/350mm) and in some cases they also demonstrate methods of early repair which appear to have included a form of reinforcement with metal bars. The original construction of the whole track was not reinforced, with the only early reinforced sections being that of the Hennebique Bridge at the north end of the race track, c.1906/7.

Fig 5.73 - Curving section of Byfleet Banking with the concrete bays clearly identifiable.

5.8.4 A consequence of the concrete being laid in bays, which itself is a significant factor in the character of the track, is the large number of resultant joints, which have opened up over time and become obscured by a number of grasses, plants, mosses and weeds – the most prolific on this section of track being Evening Primrose (*Oenothera*). The ongoing growth of the vegetation inevitably leads to localised decay to the perimeter of each concrete bay which consequently provides greater opportunity for more harmful vegetation to become established.

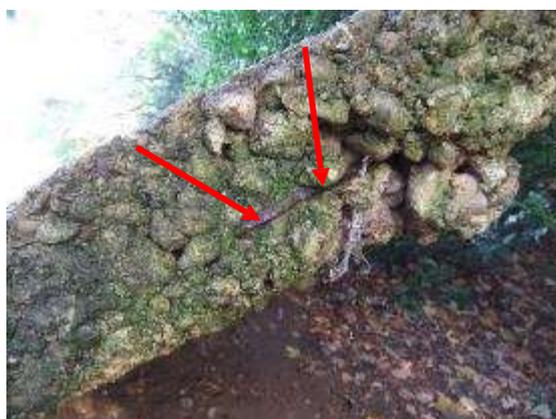
Fig 5.74 - Evidence of bar reinforcement to the now unsupported top of the banked track (southern end).

- 5.8.7 Where upper areas of track are no longer properly supported as joints between bays have significantly eroded and the support banking has been washed away beneath or eroded, further consideration will be required as to the best method of ground consolidation and making good the joints. This Plan will help assist with understanding these assets and guide the specialist consultants who, in consultation with Historic England, will be able to identify the most appropriate methods of repair and structural support to ensure that the necessary permissions are also in place when carrying out any remedial works.

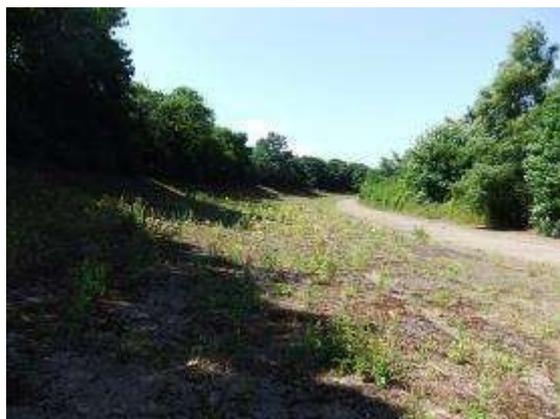
Fig 5.75 - Grasses and Evening Primrose growing through open joints of the track bays. Lichens and mosses cover the track surface.
(Radley House Partnership)

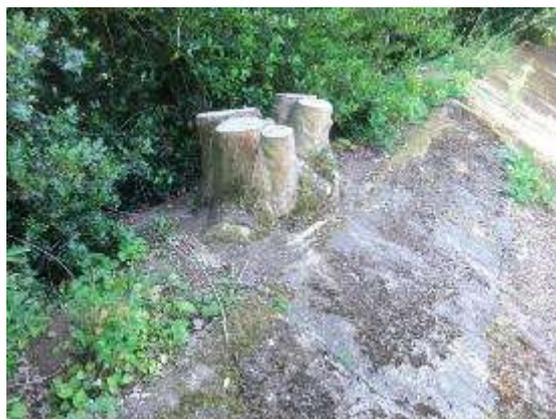
Fig 5.76 - Tree growth adjacent to the upper track edge has damaged the track surface, with localised concrete repairs clearly evident.
(Radley House Partnership)

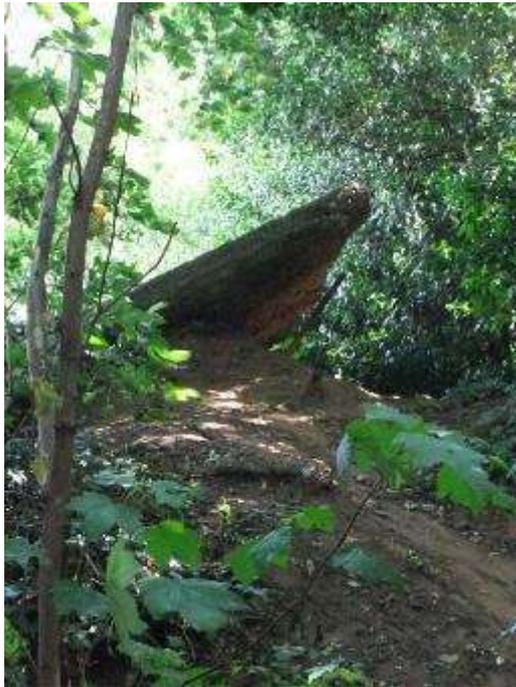
Fig 5.77 - Unsupported upper section of Byfleet Banking (southern end) following the erosion and washing away of the support banking below.
(Radley House Partnership)

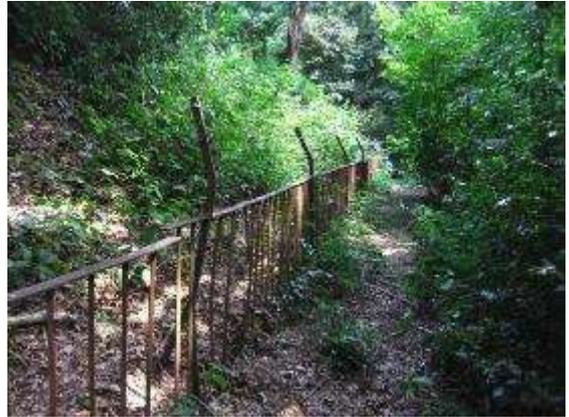
- 5.8.8 Finally, one of the more obscured elements of this section of the Byfleet Banking, which has been briefly referred to above, is that of the 'Bayliss' iron railings which run outside the track along the complete lower perimeter of the support banking – originally demarcating the site boundary of the race track. Based on the site appraisal carried out for this Plan, it would appear that this section of railings is the most complete original section which still remains today, as elsewhere only shorter disparate sections were found. Now hidden away within the 'secondary woodland' area of the Community Park, these railings have suffered through neglect and damage with corrosion and movement to their components clearly evident. Localised changes in ground levels and the growth of the trees and shrubs on the support banking has led to the base of the railings becoming buried in some locations and the deflection/failure of other sections – so much so that some trees have even grown through and around the railings consuming elements within their trunks. Also of concern is the relatively recent damage to the railings through the unauthorised removal of the heads of the railings, through Health & Safety concerns. Not only has this led to the loss of original historic fabric, but it has also damaged the remaining metal work through exposure of unprotected cut metal (which is now corroding), scarring and damage to the upper bars as a result of the fundamentally wrong use of an angle-grinder, which in the worst cases has also led to some railings springing open due to the loss of their integrity.

Fig 5.78 - Remains of 'Bayliss' iron railings along the lower perimeter of the support banking.
(Radley House Partnership)

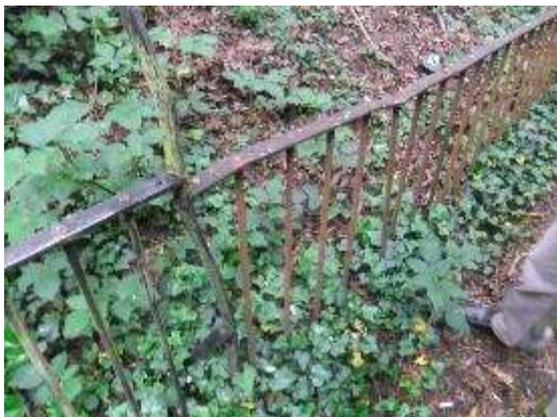
Fig 5.79 - Tops of railings removed as the result of Health & Safety concerns, exacerbating further corrosion and causing scarring to the top rail.
(Radley House Partnership)

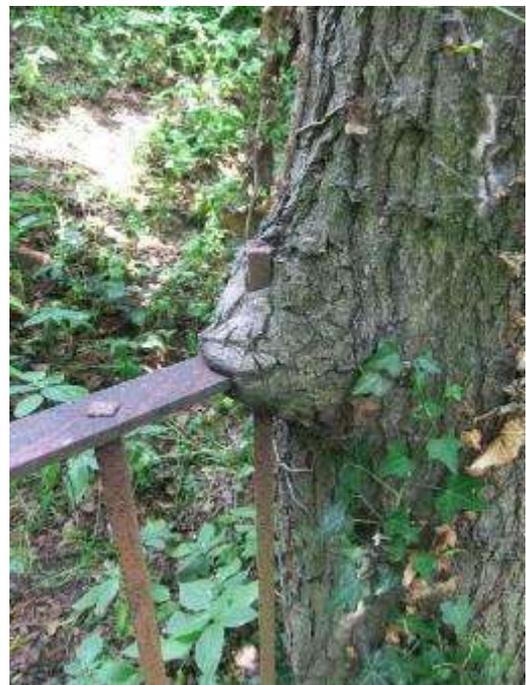
Fig 5.80 - Sections of railings being consumed by the growth of the trees along the support banking.
(Radley House Partnership)

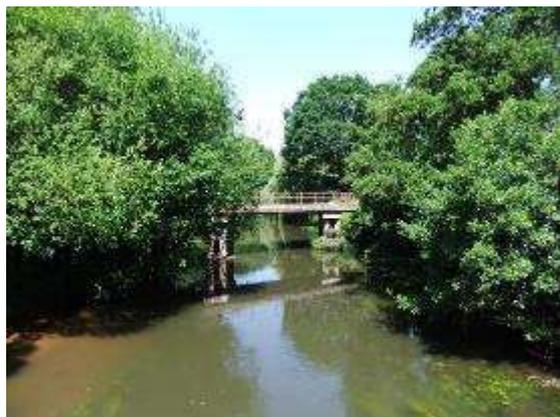
Fig 5.81 - Former Aerodrome Road Bridge crossing the River Wey.
(Radley House Partnership)

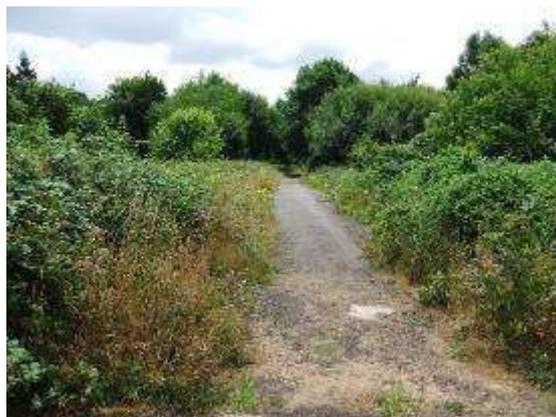
- 5.8.10 Compared with the predominantly obscured extant section of Aerodrome Road located in The Heights, this section in the Community Park is in better condition being more readily visible, fully accessible and therefore somewhat easier for the informed visitor to understand in the context of Brooklands – although the signage currently positioned around the site makes no reference to it and merely refers to it as a footpath or pedestrian route. Its width has clearly become reduced over time as the result of the encroaching vegetation which runs along both edges – to the point that it is only wide enough for pedestrians not vehicles. Also in some areas, the macadam top coat has eroded away exposing the hardcore base which in turn is becoming obscured by weed and moss growth.

Fig 5.82 - Northern end of the Aerodrome Road with its worn tarmac surface.
(Radley House Partnership)

- 5.8.11 As with the Byfleet Banking, conscious intervention is now required through the implementation of a well-managed and resourced maintenance regime. Localised clearance of vegetation is required to protect what remains of the track edges, as well as treatment of moss/grass growth to the macadam surface and localise repairs to the macadam surface – through discussion and agreement with Historic England.

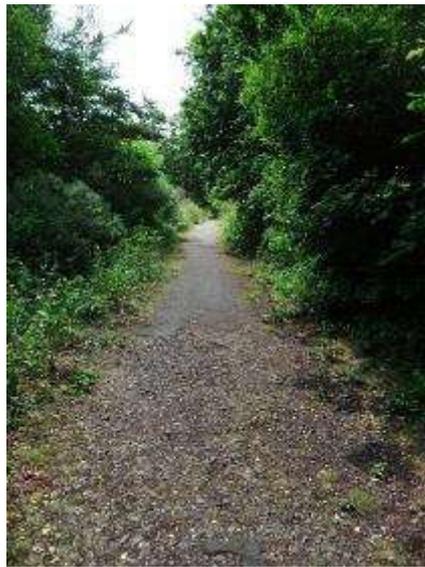
Fig 5.83 - Areas of wear and surface degradation to the tarmac finish, exposing the aggregate to the hardcore base below.

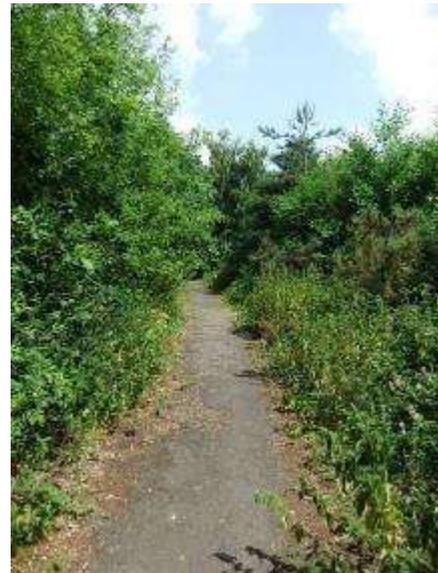
Fig 5.84 - Encroaching vegetation along the sides of the Aerodrome Road, leading to the loss of the edges and making its alignment difficult to distinguish.

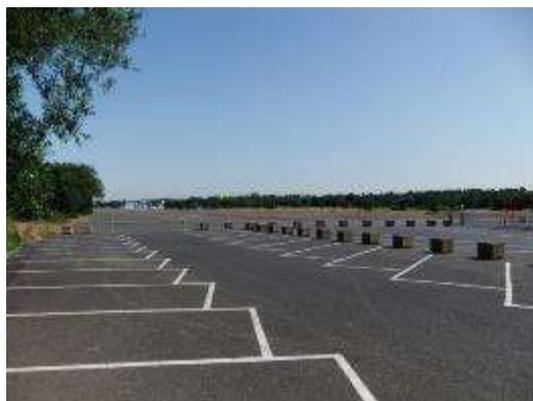
5.8.12 The third significant asset of note was constructed in 1951 and comprises the remains of the former Vickers Runway running north/south through the site and the associated aircraft taxiway at its northern end, which connects with the race track adjacent to the Cobham Bridge (used as the main access route for aircraft between the factory and airfield). Prior to this date, the airfield had a large grassed landing area similar to many others airfields with pre-WW2 origins. As aviation evolved at Brooklands, the type and size of post-war aircraft increased to the point it was necessary to add a hard concrete runway. This also meant that part of the southern section of the Byfleet Banking had to be removed to ensure that there was an unhindered flight path for the Vickers Valiant V-bomber. The main runway and taxiway are clearly defined with a relatively modern macadam surface.

Fig 5.85 - The former Vickers Runway, carrying on into the distance (north). Now partly resurfaced and sometimes used for visitor car parking.

- 5.8.14 Although the Vickers Runway does not have the same degree of statutory protection the early motoring and aviation elements, there is significance to the ‘historic’ runway surface through its record of the site’s evolution so, as with the other historic hard surfaces, consideration should be given to a maintenance regime for the exposed surface and edges in terms of localised consolidation of the latter in addition to the clearance and treatment of vegetation including cyclical preventative measures through the application of appropriate herbicides.

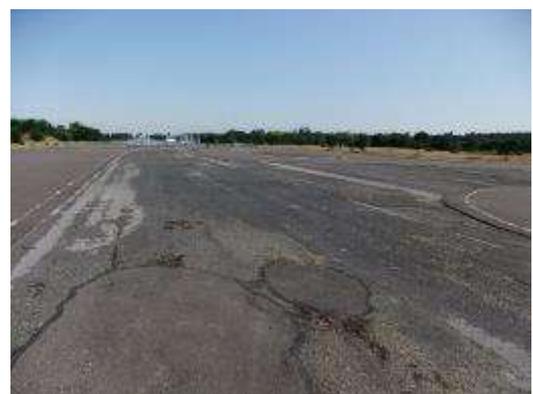
Fig 5.86 - Sections of the runway surface remain exposed in the locations of a former go-kart track.

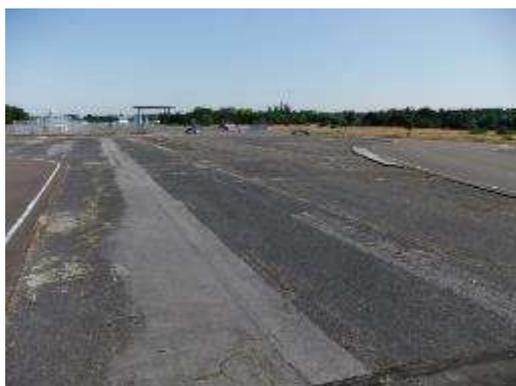
- 5.8.13 What remains of the runway now forms part of the car parking as well as part of the larger expanse of open space to the Community Park, with various play features built on top – including a children’s playground, skate park and basketball court. Previous uses on the site, after closure of the British Aerospace site in the late 1980s include a go-kart racing business who laid out a circuit (apparently without planning permission) across part of the runway and the adjoining grass – leaving significant areas of the previous runway tarmac surface exposed in the inner sections of the circuit. While the later modern top coats of macadam are generally sound, the earlier tarmac runway surface is patchy with some areas beginning to break up, evidence of previous patch repairs and areas of grass and weed growth becoming established in cracks and open perimeter joints with the go-kart track.

Fig 5.87 - Sections of the runway surface remain exposed, with the more recent re-surfacing outlining the former go-kart track.
(Radley House Partnership)

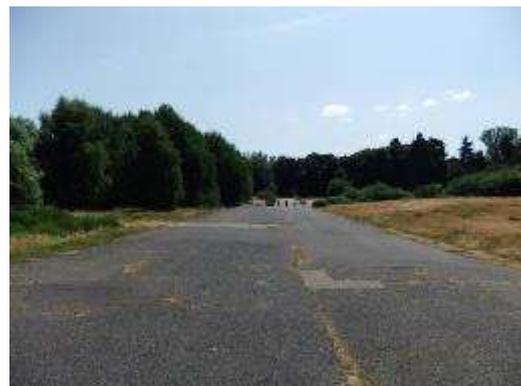
Fig 5.88 - The former taxiway at the north end of the extant section of runway – leading to the Outer Circuit in the distance.
(Radley House Partnership)

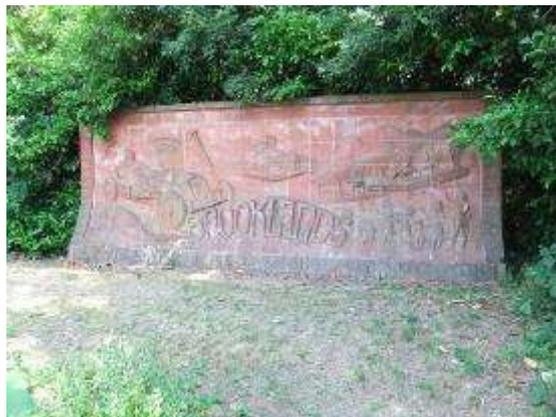
Fig 5.90 – Neglected and poorly located terracotta 'gate statement' located at the south end of Sopwith Drive.

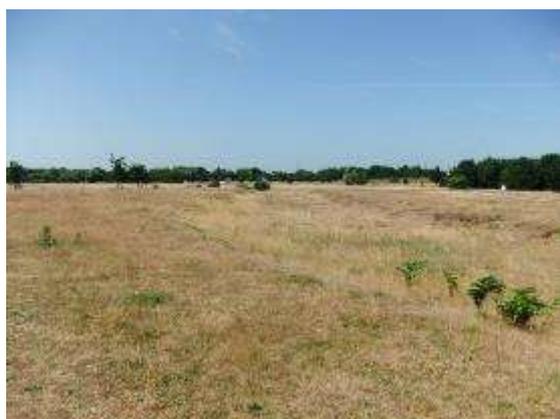
Fig 5.93 - Acid grasslands and wide drainage channels (part of the flood alleviation measures incorporated within the area).
(Radley House Partnership)

- 5.8.24 As previously referred to in the sections above, important environmental features now located within the Community Park are some of the flood alleviations measures which have been designed to address the impact of high water levels in the River Wey at the southern end of the Brooklands site. These features include two deep open original drainage gullies which run alongside both sides of the Aerodrome Road for its complete length and a wetland/pond area constructed within the open grassland to the south of the aircraft taxiway – all of which are designed to accommodate an amount of excess water when the river is in flood.

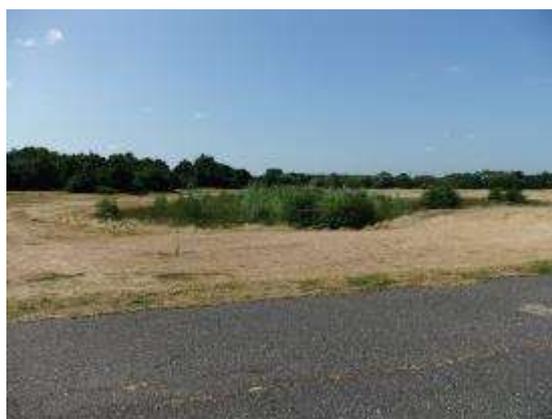
Fig 5.94 - Wetland/pond area, south of the taxiway, a key part of the flood alleviation measures for the area.
(Radley House Partnership)

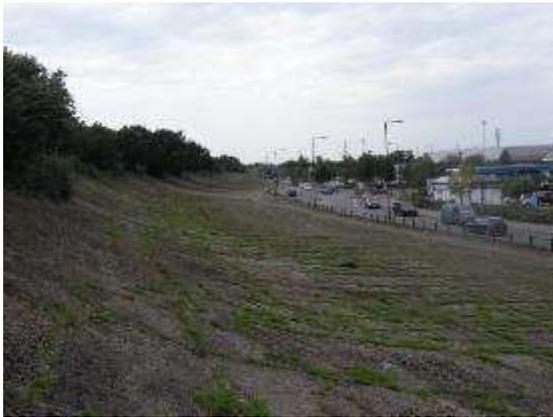
- 5.9.2 Originally forming part of the long southern banked section of the concrete race track, as a consequence of the extension of the Vickers Runway in 1951 (on its east side) and then the construction of Barnes Wallis Drive in 1990 (to the west), this now smaller section of former race track has become a somewhat isolated feature losing a degree of its context. Along its outer boundary (southern side) a limited length of the original 'Bayliss' iron railings remain along the bottom edge of the earth support banking. As noted with the other sections of race track discussed above, the regular arrangement of 10' wide bays forming the original surface are again clearly evident.

Fig 5.95 - Regular arrangement of concrete bays, forming the original surface of the race track.

- 5.9.6 As well as mosses establishing themselves across the north-facing surface of the race track and shrub growth to the western end, a recurring consequence of the way the concrete surface was formed in bays, is the ongoing decay to the bay edges as a result of the joints opening up and becoming obstructed by invasive vegetation. In addition to various grasses, Mare's Tail (equisetum arvense) is the more prevalent weed across this section of track. It is acknowledged that there is a maintenance regime in place for the clearance of vegetation from the track surface, although there have been difficulties in finding the most appropriate methods and treatments to manage the prevalent Mare's Tail.

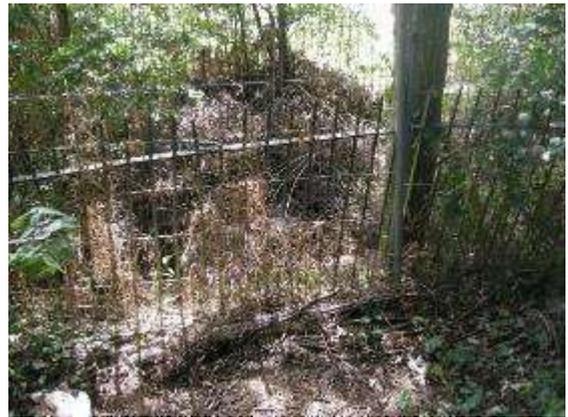
Fig 5.96 - 'Bayliss' railings at the base of the support banking to the south of the Byfleet Banking.

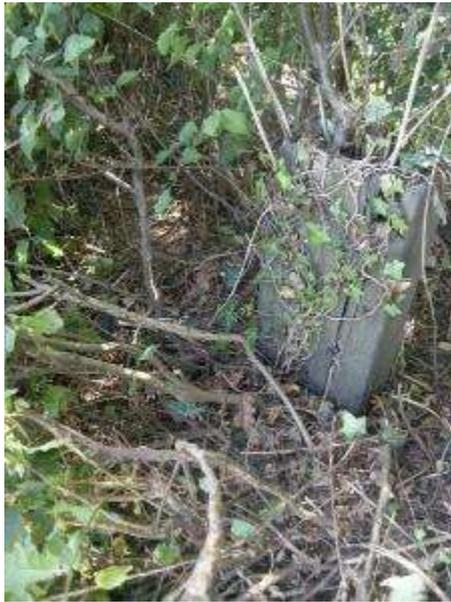
- 5.9.3 Towards the western end of this section of the Banking, partly obscured by vegetation, a series of seven concrete bases and a single vertical railway sleeper are located alongside an area of removed track edge. The vertical railway sleeper is likely to have formed part of track barrier, based on finds elsewhere (see 5.9.9 below) but the intended use of the concrete bases remains unclear, although based on historic photographs for other sections of the race track, possibly these may be the remains of supports to either previous or modern (1990s) advertising hoardings – or may relate to World War Two defences. Other war-time features are more clearly apparent along the top edge to the central section, with concrete bases and structures likely to have been gun emplacements and a related shelter structure, with another former air raid shelter built within the lower section of western banking alongside Oyster Lane.

Fig 5.97 - Remains of a railway sleeper alongside the top edge of the race track, possibly associated with advertising hoardings for the motor racing era.

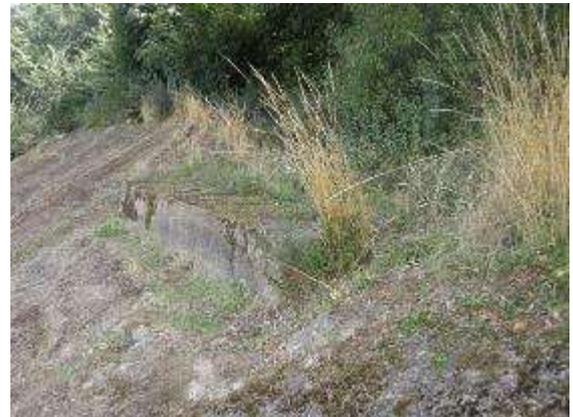
Fig 5.98 - Concrete base, associated with World War 2 defence measures, cast through the top edge of the race track.

- Fig. 5.98 Concrete base, associated with World War2 defence measures, cast through the top edge of the race track
- Fig. 5.99 Modern post and tubular rail barriers alongside the inside edge of the banking, with the scars of inappropriate interventions by utility companies to the lower sections of the race track

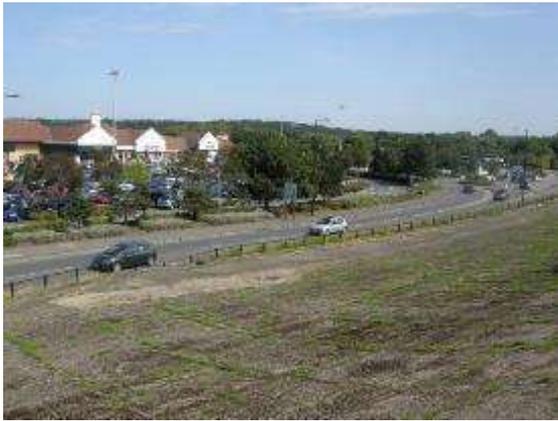
Fig 5.99 - Modern post and tubular rail barriers alongside the inside edge of the banking, with the scars of inappropriate interventions by utility companies to the lower sections of the race track.

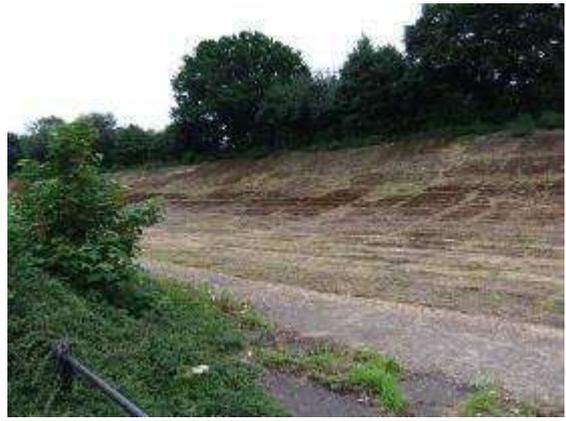
Fig 5.100 - Encroaching vegetation to the lower and top edges of the rack track, and further scars of inappropriate interventions by utility companies along the lower edge.

- Fig. 5.100 Encroaching vegetation to the lower and top edges of the race track, and further scars of inappropriate interventions by utility companies along the lower edge

- 5.9.5 Further late 20th century features scar and obscure the inside and western edges of the track. These include 'modern' (early 1990s) post and tubular rail barriers (preventing vehicle access onto the track), a concrete retaining wall/plinth and gully as well as utility services with raised access covers and unsympathetic methods of associated track repair – which all now make it difficult to identify the original extent of the race track along its lower northern edge. The 1990 infill repairs to the western edge, abutting the retaining wall associated with the construction of Barnes Wallis Drive, are also showing evidence of failure and movement with the higher sections slipping down. Utility companies should be encouraged to avoid routing services through sections of track and, if unavoidable, then to make good. All such works should be sympathetic to and appropriate to the adjoining surfaces and materials.

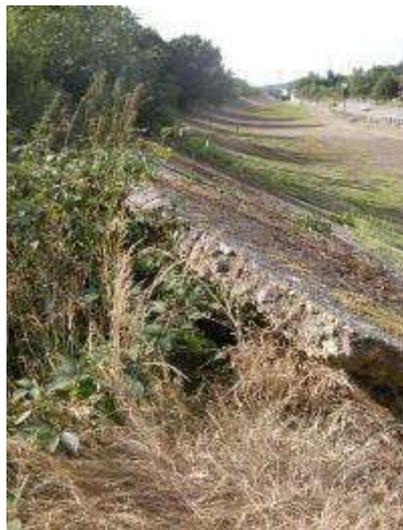
Fig 5.101 - Significant areas of undermining to the top edge of the race track as a result of burrowing animals.

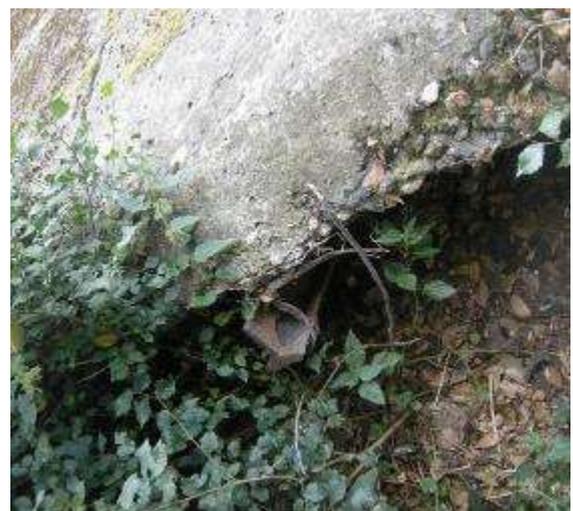
Fig 5.102 - Previous attempts to provide support to the undermined sections of banking, using metal posts.

- Fig. 5.101 Significant areas of undermining to the top edge of the race track as a result of burrowing animals
- Fig. 5.102 Previous attempts to provide support to the undermined sections of banking, with metal posts

5.9.7 As identified with the Community Park section of the Byfleet Banking, the top edge of the race track and associated support banking is also under threat and being damaged. In this case it is not only encroaching vegetation and trees that are causing this damage but burrowing animals (urban foxes, badgers and rabbits) are digging out below the concrete to form their dens and warrens which is gradually undermining long sections of race track with sections up to 1.5m deep having no support beneath. In the worst cases, this has already led to areas of slippage and partial loss of the track's edges, as well as an area of bulging in the surface towards the 1990 infill works. It would appear that the undermining of the track is a long-standing issue, with previous attempts to address this through the use of iron angles driven into the banking under the exposed track edges being visible at the eastern end of the banking. Structural movement and de-stabilisation of the track surface should be monitored and consideration given to implementing appropriate methods of stabilisation – specialist consultants should liaise with Historic England to agree methodologies and materials.

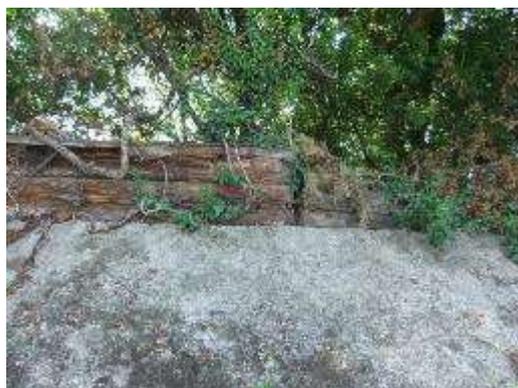
Fig 5.103 - Unique survival along the top edge of the race track, in the form of the remains of the former 'track kerbing'.
(Radley House Partnership)

- Fig. 5.103 Unique survival along the top edge of the race track, in the form of the remains of the former 'track kerbing'
- Fig. 5.104 Further remains of the 'track kerbing' with the metal sheet facing corroding and coming away from the timber sleepers

- 5.9.9 A unique and notable survival of Brooklands' motor racing era can now only be found on this section of track, along the top edge towards the southern end of the banking – the original 'track kerbing' and early form of 'crash barrier'. This comprised vertical timber railway sleepers driven into the earth banking behind the concrete track, two layers of horizontal railway sleepers were then laid across the back edge of the top of the track, fixed through to the vertical members behind before being faced with flat sheets of metal. The surviving section is now partially obscured by encroaching vegetation and understandably suffering from timber decay and metal corrosion. These unique extant sections of track detailing are a historically important feature and therefore deserve to be carefully cleared of vegetation and fully recorded then, should funds permit, consideration could be given to their conservation in-situ to help prolong their future.

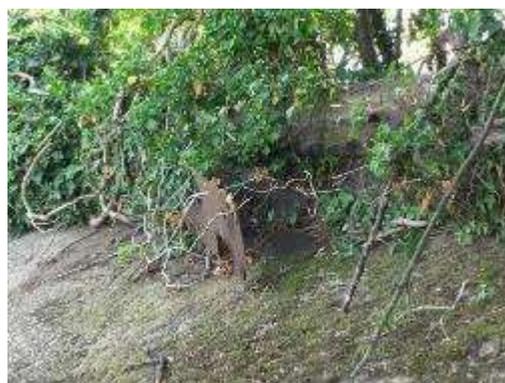
Fig 5.104 - Further remains of the 'track kerbing' with the metal sheet facing corroding and coming away from the timber sleepers.
(Radley House Partnership)

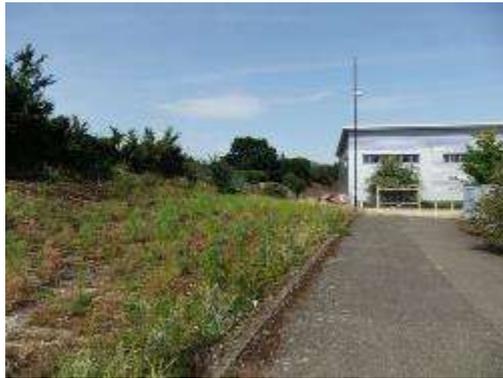
Fig 5.105 - Modern tarmac surfacing laid along the inside edge of the race track, with restrictive access gateway and bollards in the distance. Mare's Tail and other scrub vegetation obscures the track surface.
(Radley House Partnership)

- Fig. 5.105 Modern tarmac surfacing laid along the inside edge of the race track, with restrictive access gateway and bollards in the distance. Mare's Tail and other scrub vegetation obscures the track surface

- 5.9.11 More recent unsympathetic and possibly unauthorised works include the application of modern tarmac with concrete kerbing, bollards and security gates to form an access road surface along its inner eastern edge (at the northern end of the track) as well as the installation of utility service routes and drainage which have inevitably destroyed and obscured the alignment of the original inner edge of the race track. As with the southern section of the Banking, the section of track abutting the retaining wall to Barnes Wallis Drive, is also showing evidence of ground movement with sections of the track surface dropping – this is clearly evident displayed with the failure of a mastic type sealant which has been applied across the wall/track junction. As part of the construction of this retaining wall c.1990, a reveal was also deliberately formed at low level to allow members of the public to view a section through the race track – however well-intentioned this may have been, the lack of maintenance and effort to clear this sections in combination with a lack of explanatory information means this is now obscured by litter and vegetation.

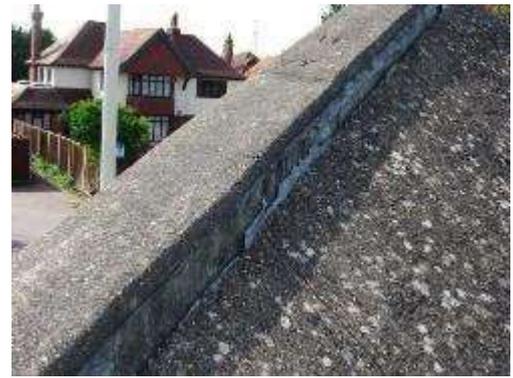
Fig 5.106 - Failed mastic type sealant at the abutment of the former track edge and the retaining wall to Barnes Wallis Drive, clear evidence of movement in the track surface.
(Radley House Partnership)

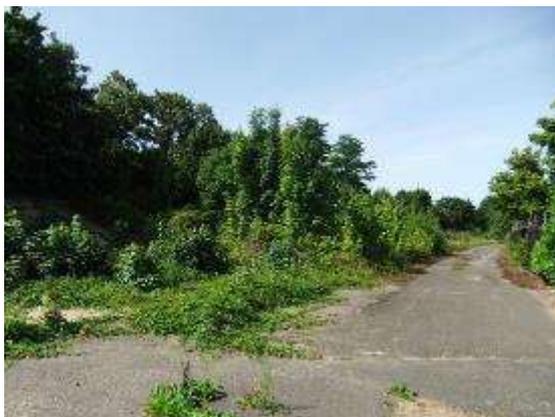
Fig 5.107 - Dense vegetation and tree growth established across the track surface. Condition and extent of any further historic remains within this area are unknown.
(Radley House Partnership)

- Fig. 5.107 Dense vegetation and tree growth becoming established across the southern sections of the track surface. Condition and extent of any historic remains within this area are unknown

5.9.12 As commonly noted elsewhere mosses, grasses and various weeds are already well established across the track surface and in the joints between the bays of concrete, with Mare's Tail (equisetum arvense) again being the more prevalent weed across the northern end of the track. However, this section of the race track has a greater amount of cover from the denser weed growth and brambles throughout, but of greater concern is the quantity of tree saplings and young trees (including Sycamore and Silver Birch) which are increasingly established towards the southern end. The density of the tree and shrub growth in this area prevented access to fully assess the condition and extent of the remaining concrete track surface – and considering how dominant this growth has become, there is a high risk that the concrete surface is already badly broken up, potentially beyond recognition. As a priority, dense woody growth and vegetation should therefore be carefully cut back and cleared to allow closer inspection of the track to determine what, if anything, still remains in these areas. A more pro-active approach should then be adopted with the removal of inappropriate vegetation and implementation of cyclical preventative measures through the application of appropriate herbicides. This section of race track is also regularly used as a short cut between Wintersells Road (to the north-west) and Barnes Wallis Drive (to the south), which leads to increased litter problems and on occasion small scale fly-tipping at its southern end.

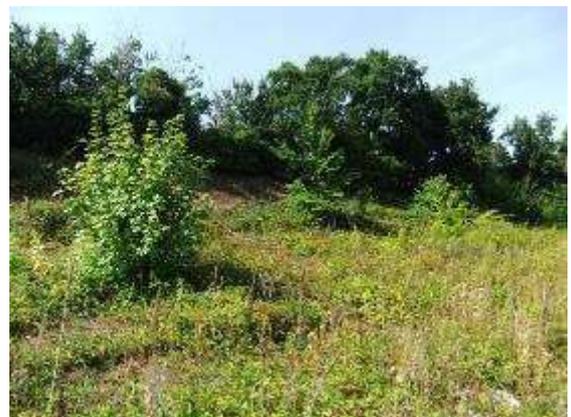
Fig 5.108 - Tree saplings, brambles and weed growth dominate the Byfleet Banking's south-western section.
(Radley House Partnership)

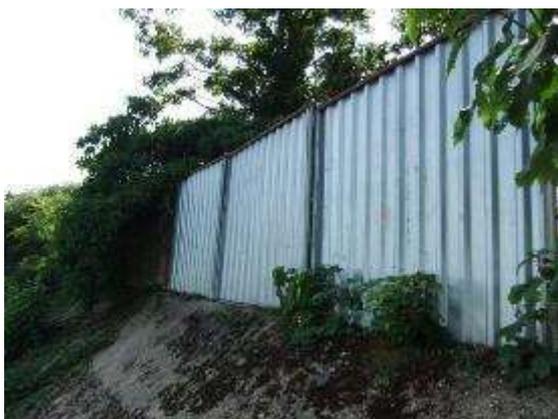
Fig 5.109 - Inappropriate temporary metal hoardings erected along the track edge behind new residential properties along Oyster Lane.
