BROOKLANDS AERODROME & MOTOR RACING CIRCUIT

CONSERVATION MANAGEMENT PLAN

Brooklands Heritage Partnership

October 2017

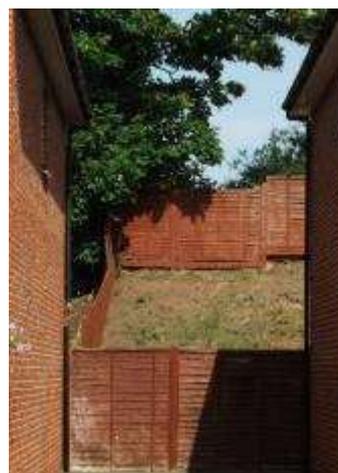
Fig 5.110 - Exposed support banking behind residential properties and modern timber panel fencing erected near to the track edge (viewed from Oyster Lane).

- Fig. 5.110 Exposed support banking behind residential properties and modern timber panel fencing erected near to the track edge (viewed from Oyster Lane)

- 5.9.13 As discussed elsewhere with the southern section of the Byfleet Banking, the top edge of the race track and associated support banking are also susceptible to being damaged as a result of animal activity as well as encroaching vegetation and trees. Shrub and tree growth is evident along the top of the track, as are mature trees on the banking beyond. The density of the shrub growth and a 'modern' chain-link fence positioned very close to the track edge, made it difficult to fully inspect the top edge at the northern end of the track yet it was clear that there was some localised damage and loss to the surface as a result of uncontrolled tree growth. To the south, while vegetation was lighter, modern inappropriate temporary metal panels have been positioned along the top of the bank and modern timber boarded fence panels have been constructed in the bank at high level very close to the track edge. Limited access to the private land beyond also meant that the support banking to this section of the track could not be properly assessed. Dense vegetation and tree growth obscures the northern end, with only glances of the banking to the south being possible between the new residential properties on Oyster Lane. It was noted here that the now cleared earth support banking appeared to be steeper than found elsewhere, although without a point of reference, it is difficult to determine whether any of the support banking has been removed to form a larger garden for the new residential properties and so potentially undermining the race track beyond. Further assessment is necessary to properly assess what, if any, undermining to the top of the track may have occurred and whether the current degree of incline to the banking has been increased to facilitate improved private garden areas to the new residential properties, potentially further compromising the stability of the banking in the long-term.

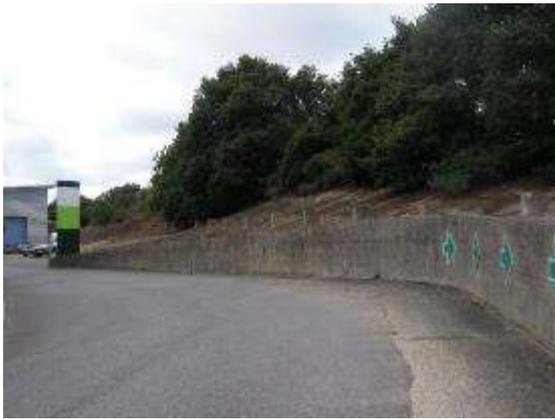
Fig 5.111 - Inner edge of the track, lost when BAC built new industrial facilities here in the early 1960s. Concrete bases supported services to this area of the aircraft factory.

- Fig. 5.111 Inner edge of the former race track, lost as a result of subsequent redevelopment works including the construction of an access road. Concrete bases, cut through the track relate to the Vickers-Armstrong's occupation of the site

- 5.9.15 The inner edge of the track appears to have been lost completely along this section, with 'modern' concrete retaining walls and kerbing built into the line of the track (most noticeably at its northern end although this was largely done by BAC when constructing two vast VC10 Flight Sheds in the early 1960s), to allow the buildings and parking to be built along with the access road to pass through. More recently with the Trade City development, gravel has been laid over a geotextile membrane where the inner concrete track bays have been lost. At the southern end, it would appear that a series of the former concrete bays have been completely removed or degraded with only gravel and vegetation now evident. Also at this end, a series of bays along the top of the track also appear to have been removed – it is unclear whether this was due to collapse or if it was intentional and associated with the World War Two gun emplacement that was built in this area across and through the race track.

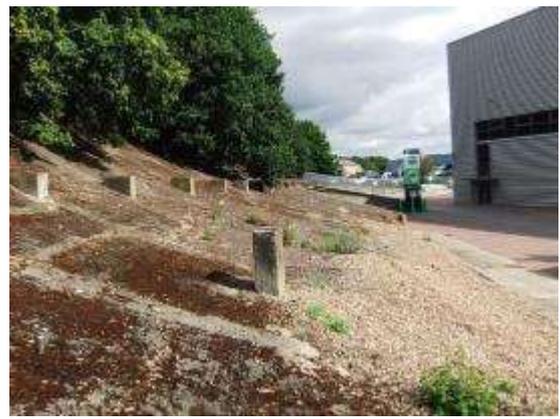
Fig 5.112 - Gravel has been laid over a geotextile membrane in the location of the lost inner edge to the track.

- Fig. 5.112 Gravel has been laid over a geotextile membrane in the location of the lost inner edge to the track
- Fig. 5.113 Ivy covered World War 2 gun emplacement cut through the track with top edge beyond also removed

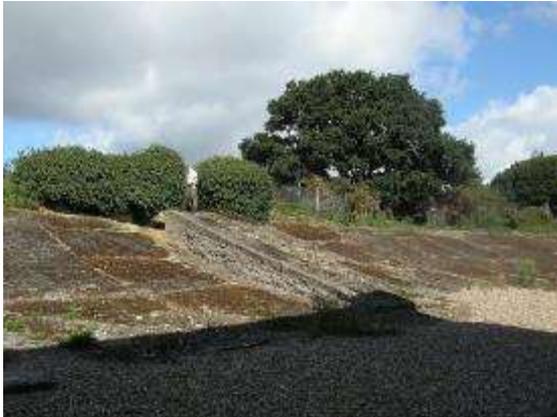
Fig 5.113 – Ivy covered World War 2 gun emplacement cut through the track with top edge beyond also removed.

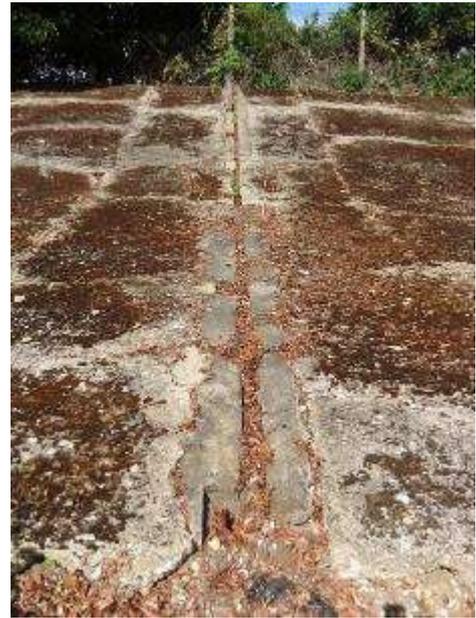
Fig 5.114 - Scar running through track, indicative of a former fence line with post holes to the left of the main groove cast through the surface.

- Fig. 5.114 Scar running through track, indicative of a former fence line with post holes to the left of the main groove cast through the surface
- Fig. 5.115 Areas of collapse and undermining to the top edge of the banked track

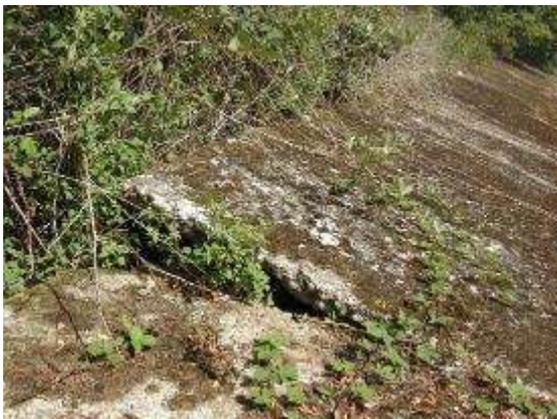
Fig 5.115 - Areas of collapse and undermining to the top edge of the banked track.

- 5.9.17 A modern chain-link fence with concrete posts has been built close to the top edge of the track, with shrub, tree and brambles evident along this area and the support banking beyond. Again the density of the plant growth made it difficult to fully inspect the top edge of the track in some locations but it was clear that there is some localised damage in terms of fracturing and partial collapse to the top edges of the race track. Limited access to the land beyond also meant that the support banking to this section of the track could not be fully assessed – although at its southern end, terracing and earth ramps have been constructed around the area of a related former war-time gun emplacement. Clearance of vegetation and further assessment would be necessary to properly assess the extent, if any, of undermining to the top of the track that may have occurred. Consideration can then be given to implementing appropriate methods of stabilisation – for which specialist consultants should liaise with Historic England to agree methodologies and materials.

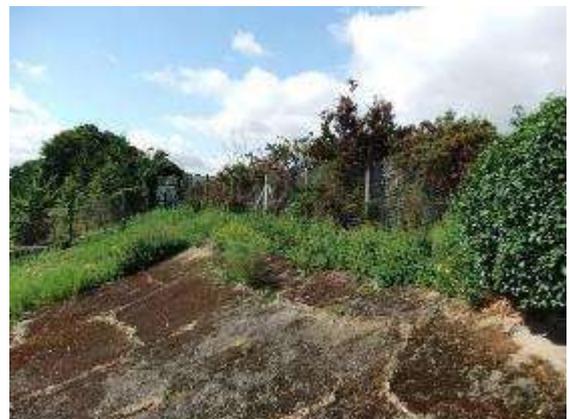
Fig 5.116 - Unmanaged vegetation, weed growth and mosses established around and across the surface of track.

- Fig. 5.116 Unmanaged vegetation, weed growth and mosses becoming established around and across the surface of the track
- Fig. 5.117 Front (east) view of the former Aero Clubhouse, now converted to offices

5.9.18 As well as mosses becoming well established across much of the surface of remaining race track in this area, the weed growth along track joints is less of a problem here compared to elsewhere. However, any collapsed and missing sections of track are becoming overrun with various weeds, grasses and brambles. A pro-active approach should be adopted with the removal of inappropriate vegetation and implementation of cyclical preventative measures through the application of appropriate herbicides.

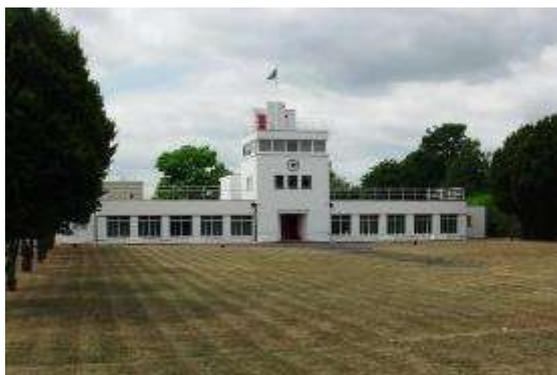
Fig 5.117 - Front (east) view of the former Aero Clubhouse, now converted to offices.

- 5.9.21 The building is in a good condition and well maintained – it clearly benefits from having a tenant who not only partly occupies the building, but also shares an interest in the history of Brooklands and the former Aero Clubhouse itself.

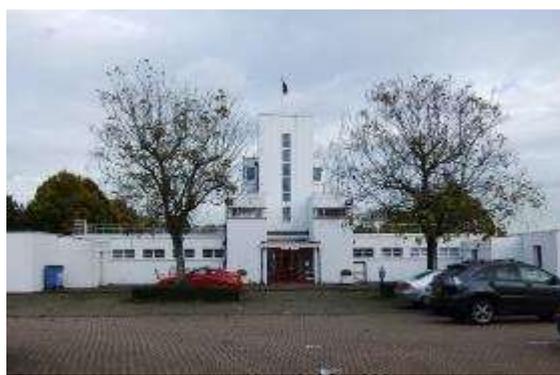
Fig 5.118 - Rear (west) view of the former Aero Clubhouse, office tenant car parking in the foreground.

- Fig. 5.118 Rear (west) view of the former Aero Clubhouse, office tenant car parking in the foreground
